# Supervisory Guidance for Water Suppliers in Japan

Water Supply Division,  
Health Service Bureau,  
The Ministry of Health, Labor and Welfare

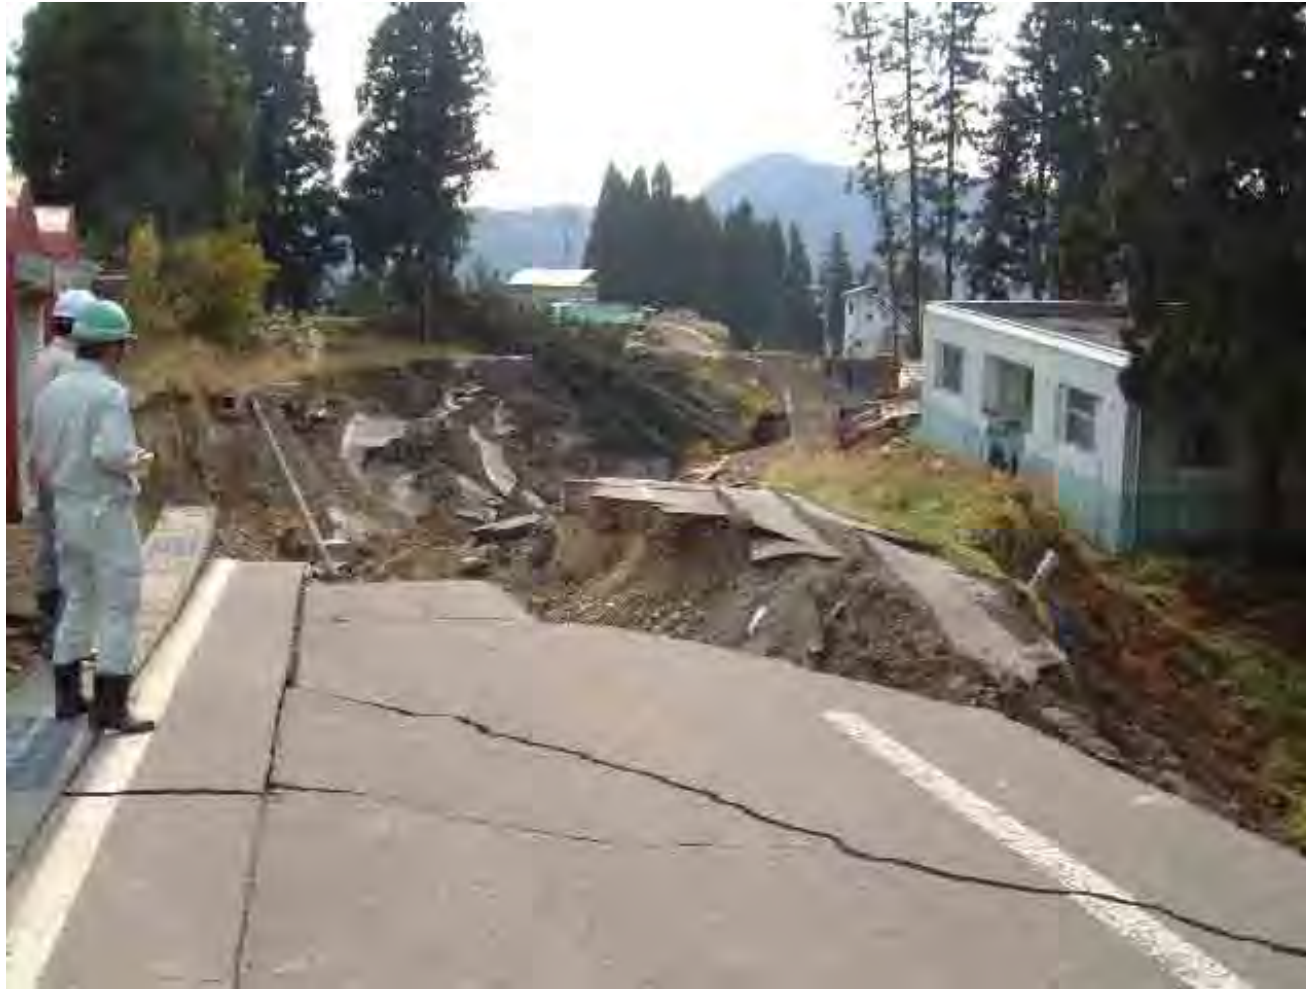
## 4-2 Niigata Chuetsu Earthquake, October 2004

Damaged road: cave-in

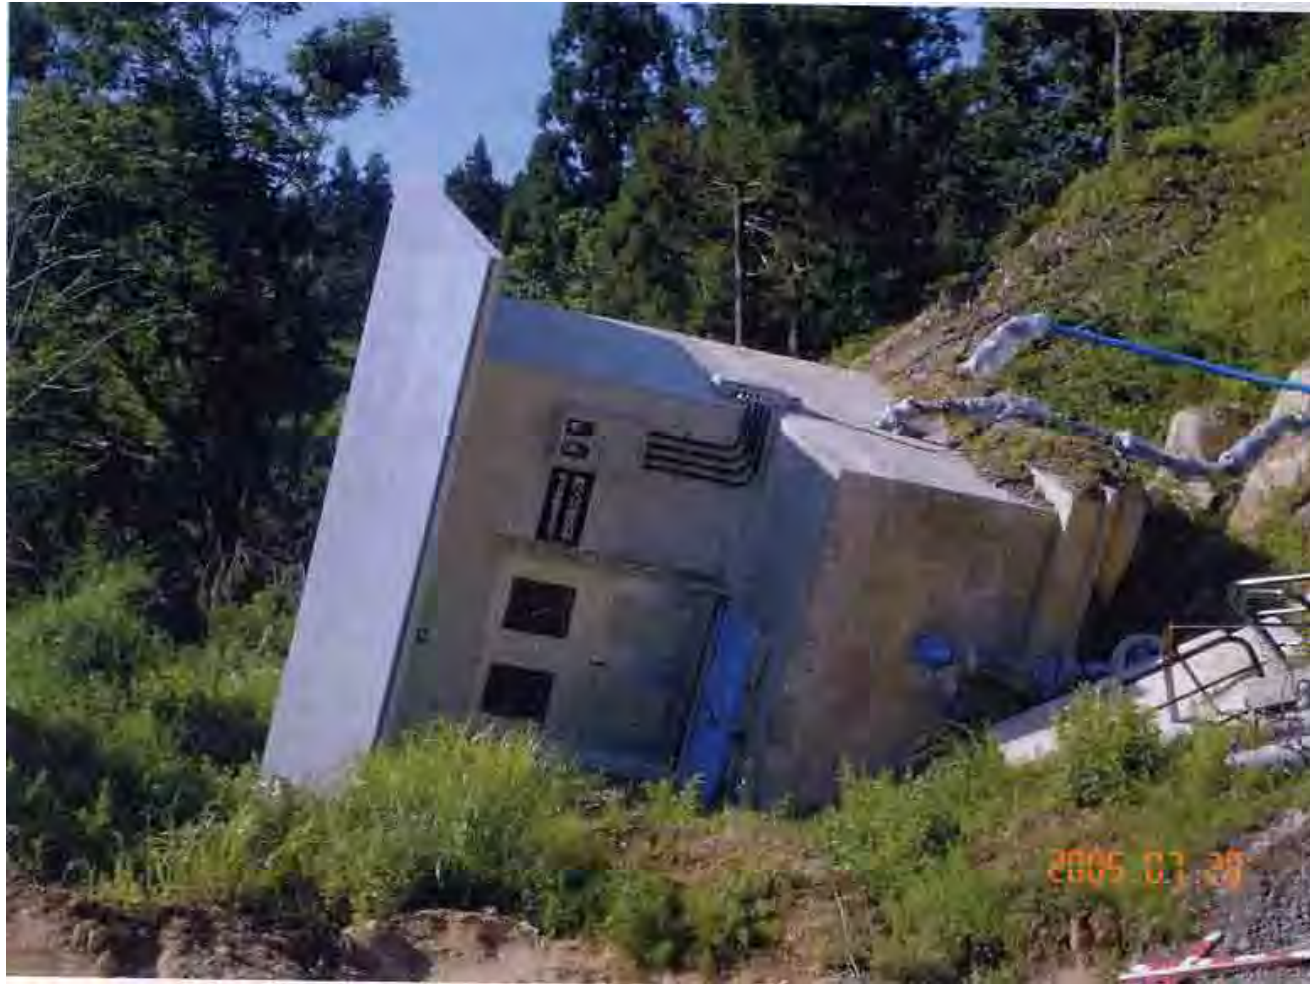
## 4-3 Niigata Chuetsu Earthquake, October 2004

Collapse of an equipment shed

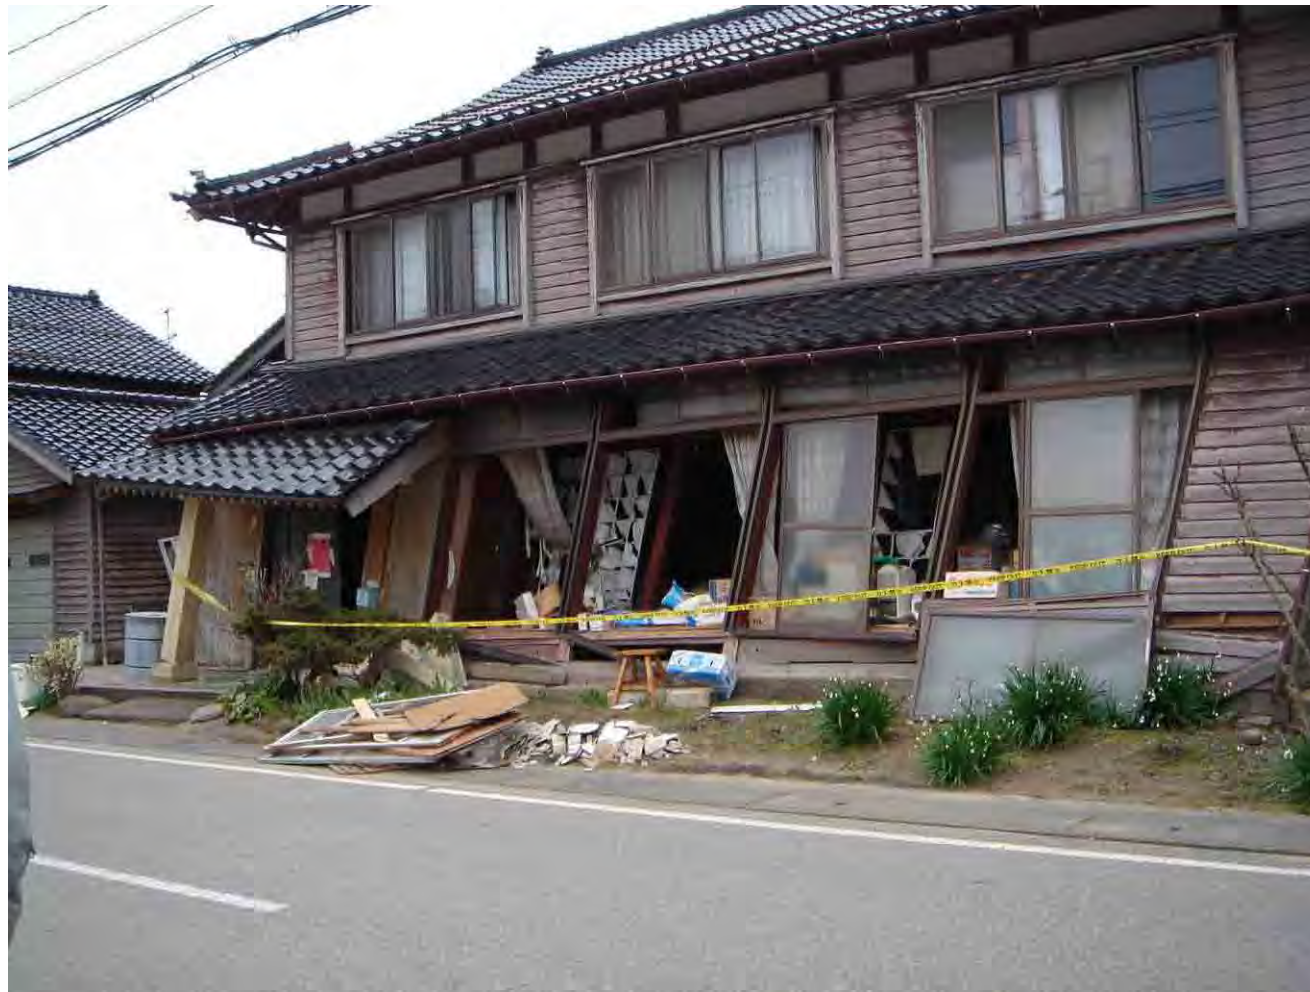
## 4-4 Noto Peninsula Earthquake, March 2007

A damaged house

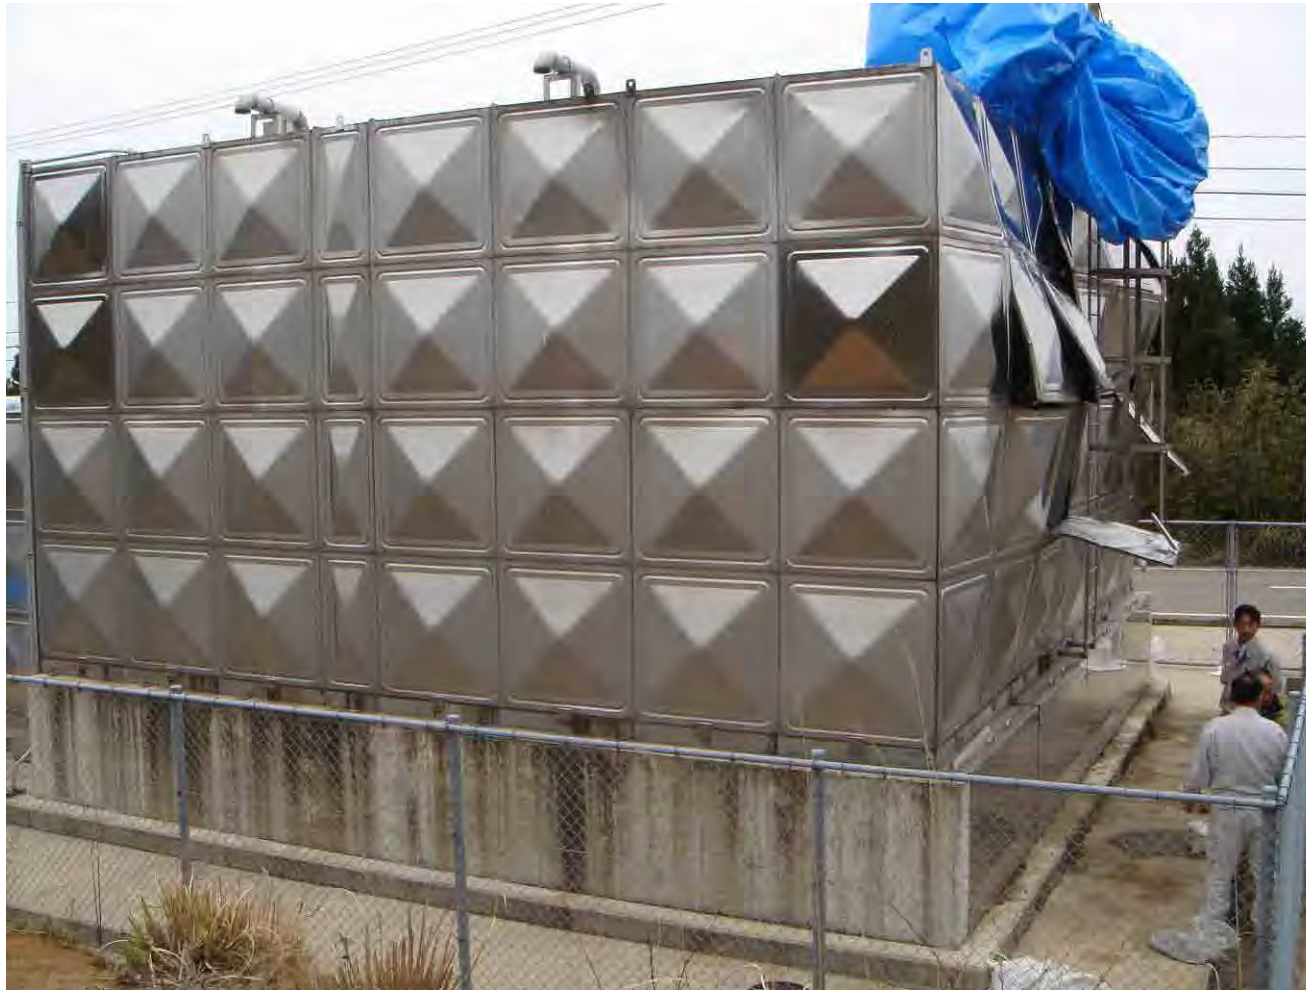
## 4-5 Noto Peninsula Earthquake, March 2007

Damage to a stainless-steel water pool

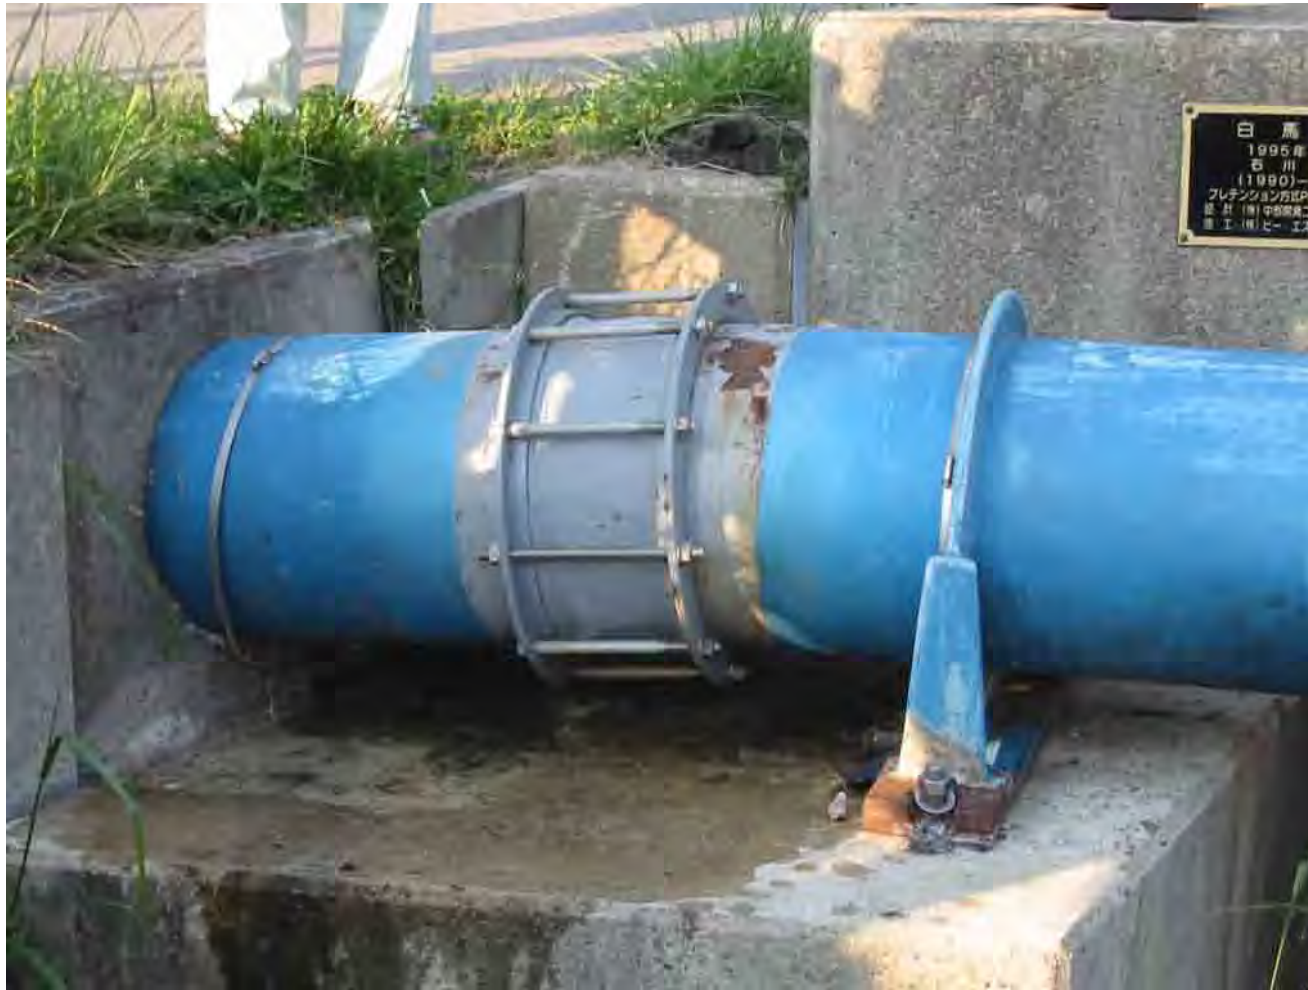
## 4-6 Noto Peninsula Earthquake, March 2007

Damage to the elastic part of a water pipe bridge

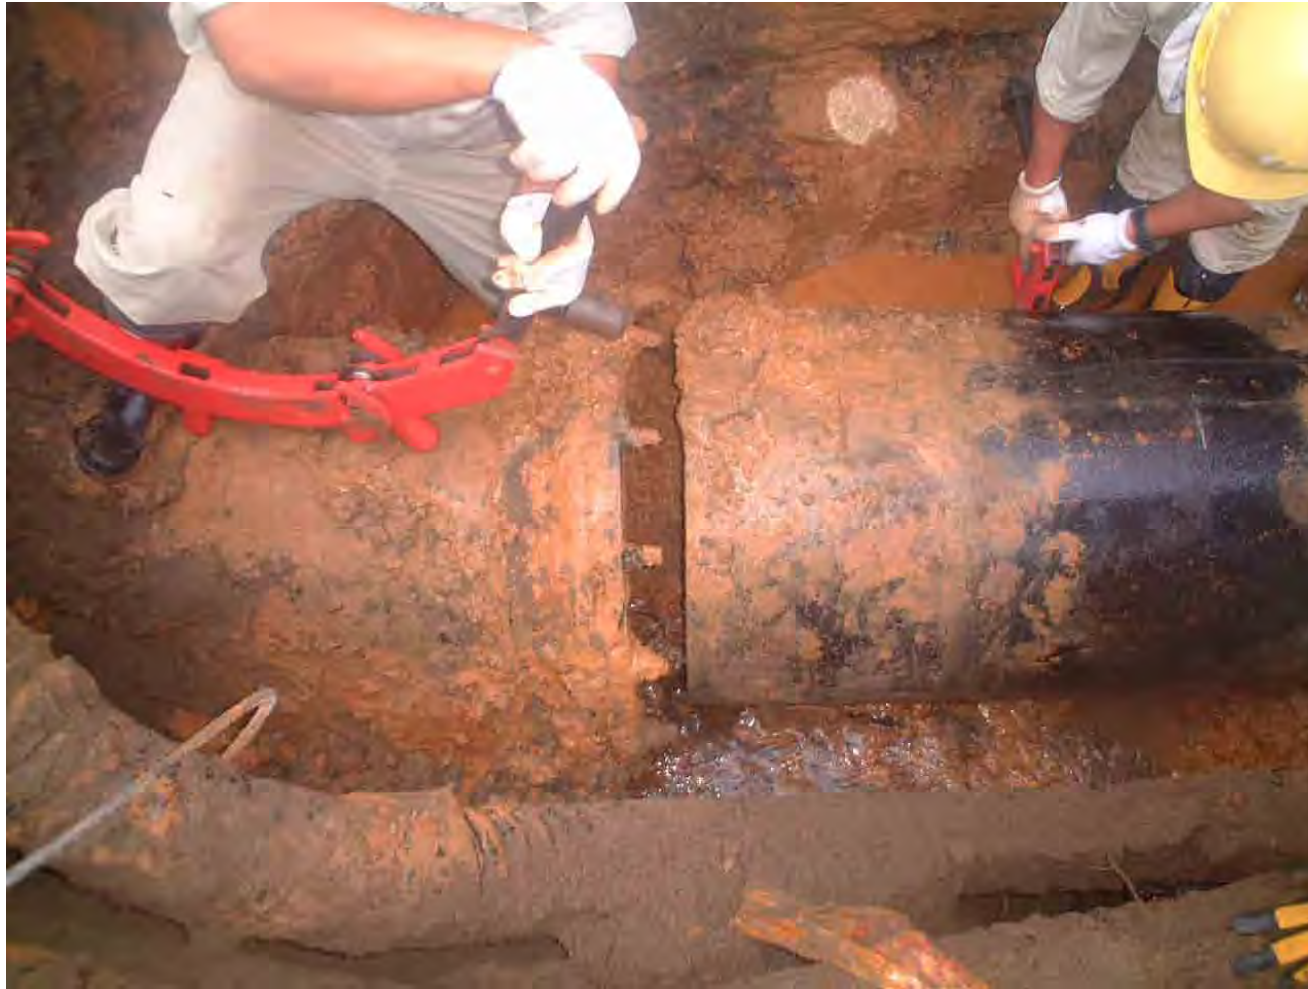
## 4-7 Niigata Chuetsu Earthquake, July 2007

A damaged road: dislocated coupling

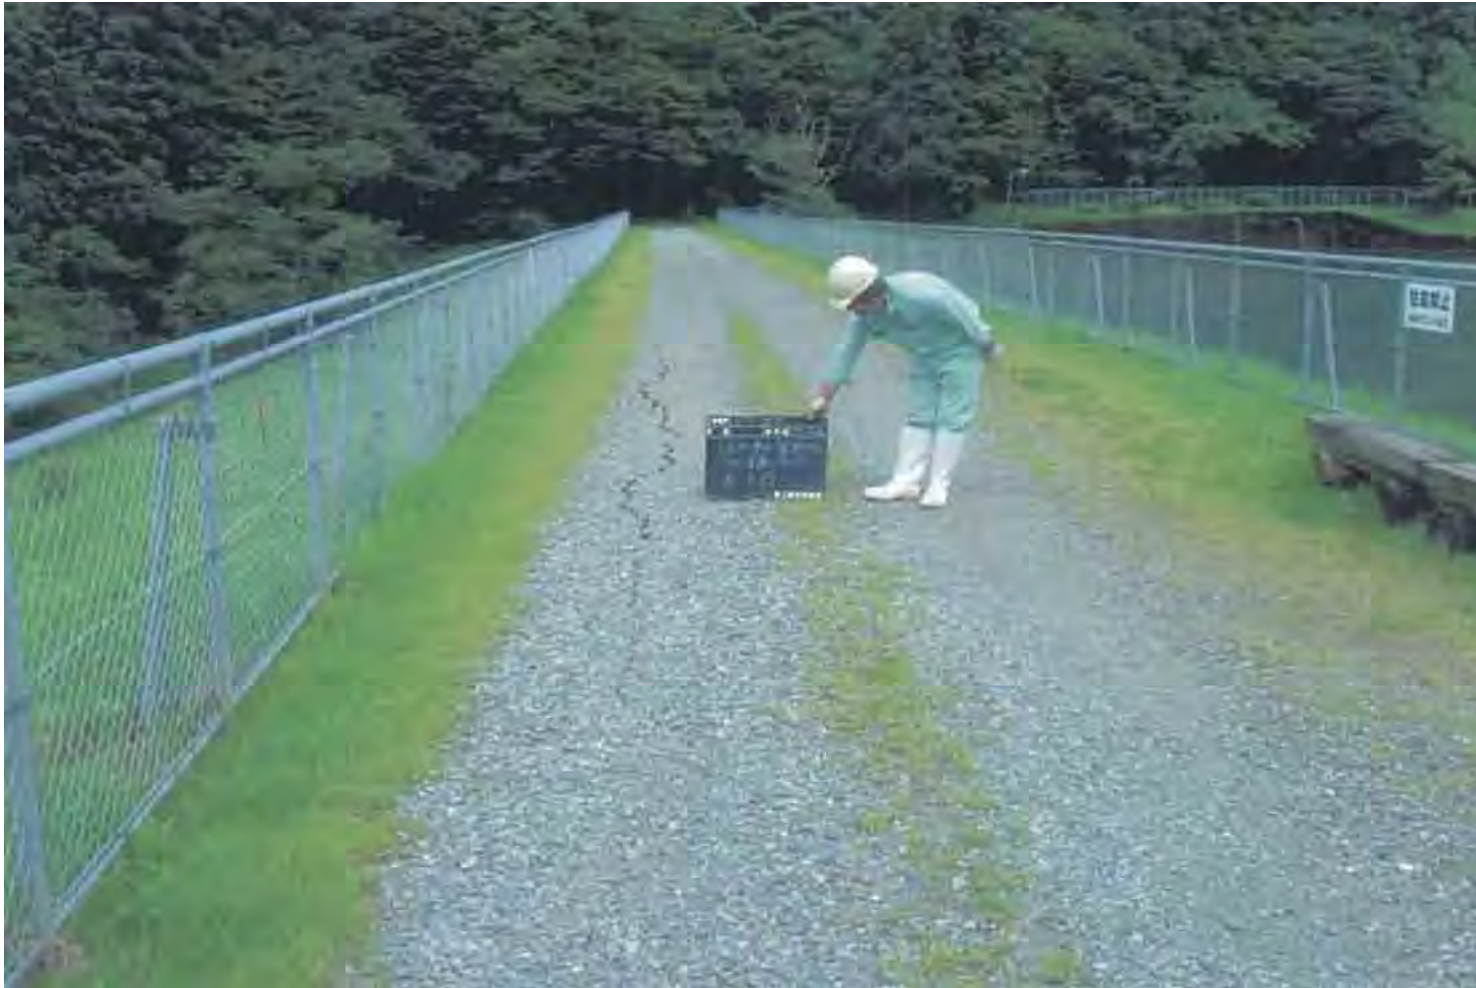
## 4-8 Niigata Chuetsu Earthquake, July 2007

A crack in the dam structure

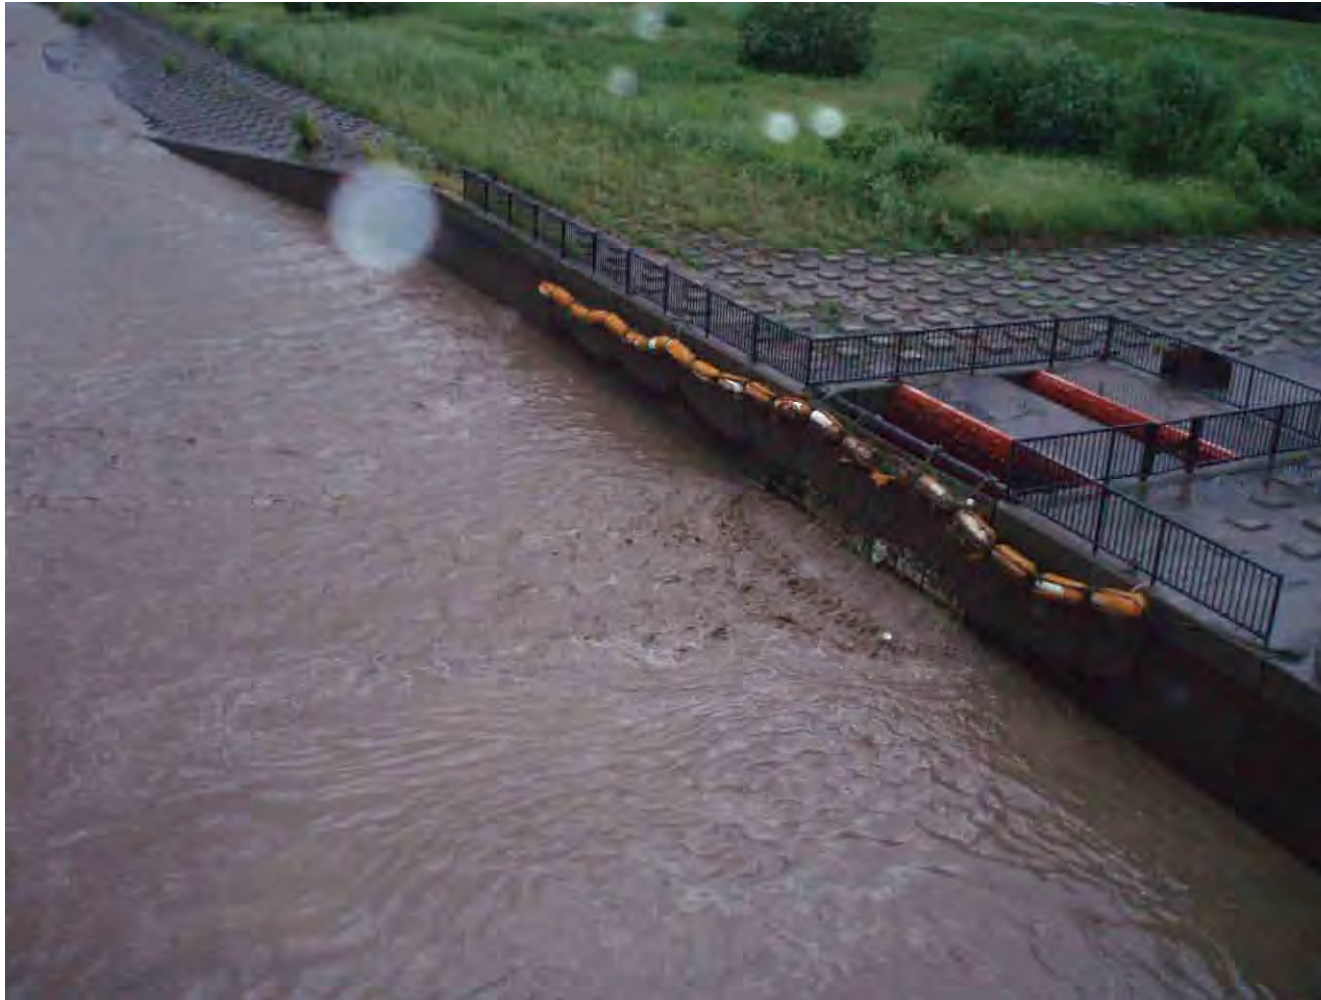
## 4-10 Water Supply Cutoff due to Significant Turbidity in Raw Water: Kitami-shi in 2007

(2) Cause: Increase in the turbidity of raw water after heavy rain in the upper reaches of the river catchment: the turbidity reached nearly 15,000 degrees, which exceeded the processing capacity. As a result, the water intake was stopped.

Muddy raw water runs through a sluice gate.

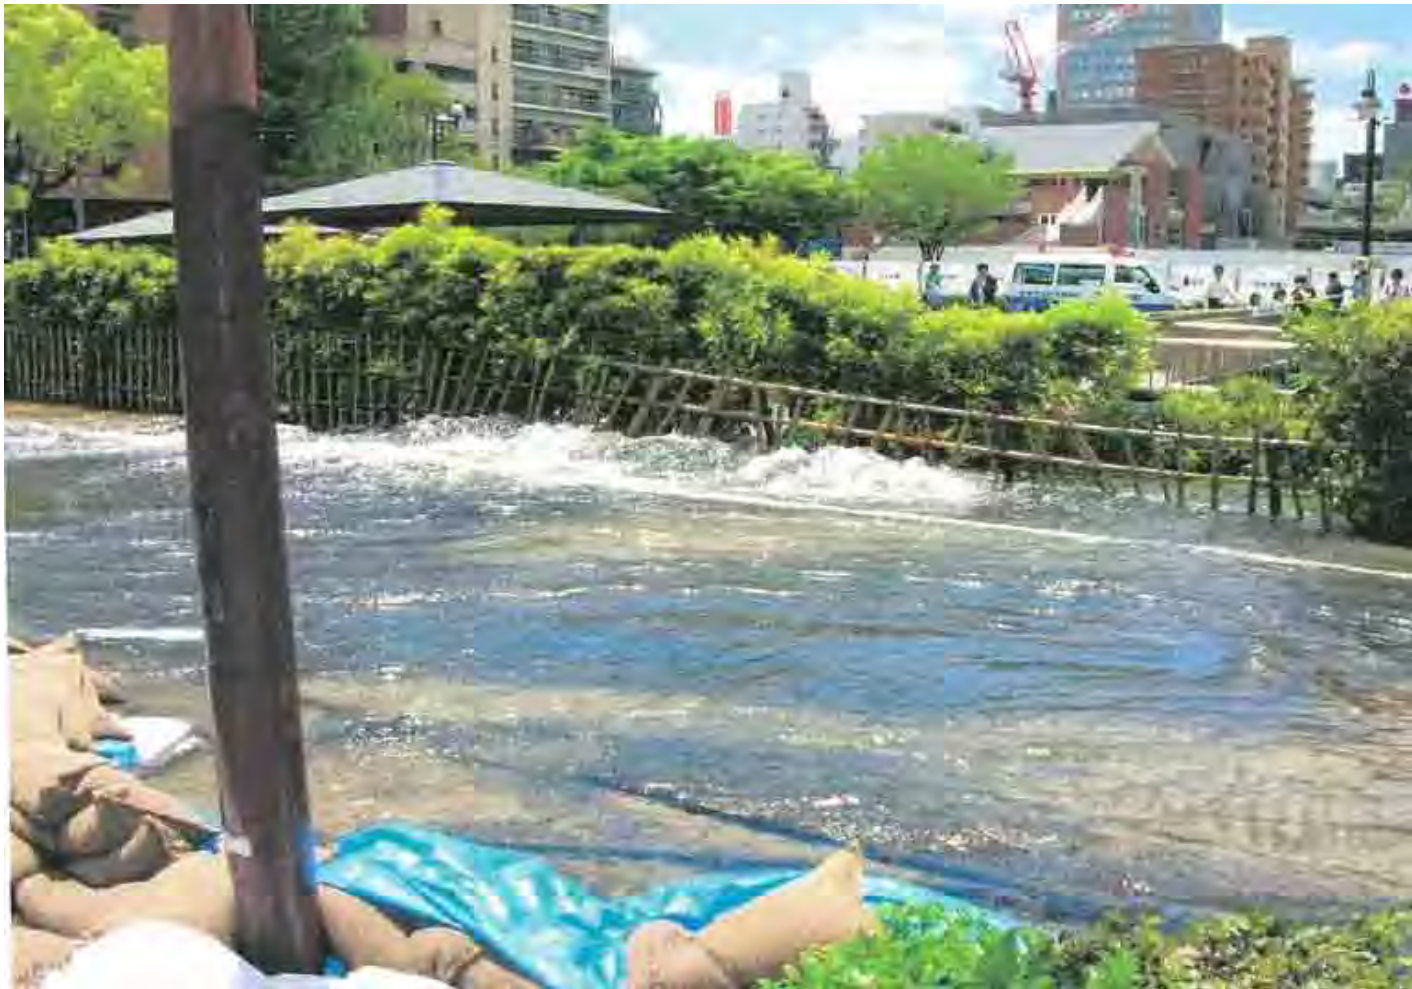
## 4-12 Water Leakage in Okayama-shi in 2007

- About 9:00 a.m., Sunday, May 20, 2007
  - A water pipe with a diameter of 1000 millimeters burst in the central area of Okayama-shi.
  - Nearly 40,000 cubic meters of tap water leaked out.
  - Nearly 72,000 households and 155,000 people suffered from low water pressure and turbid water.
-

Water leaked from an asbestos cement pipe with a diameter of 1000 mm.

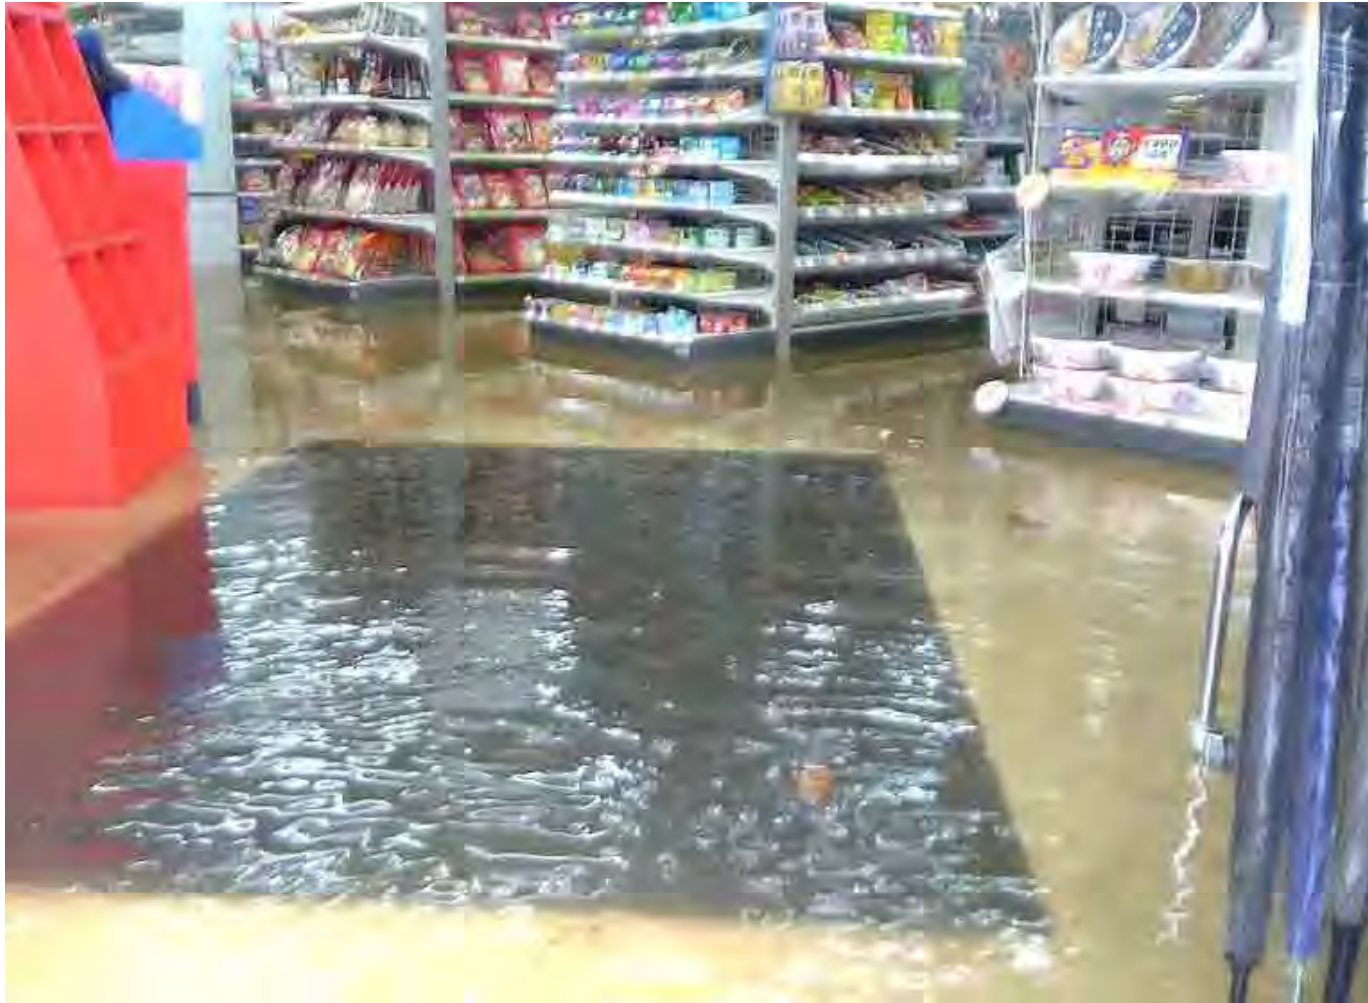
## 4-13 Water Leakage in Okayama-shi in 2007

Buildings of this area, including the shop shown below, were inundated above the floorboards.

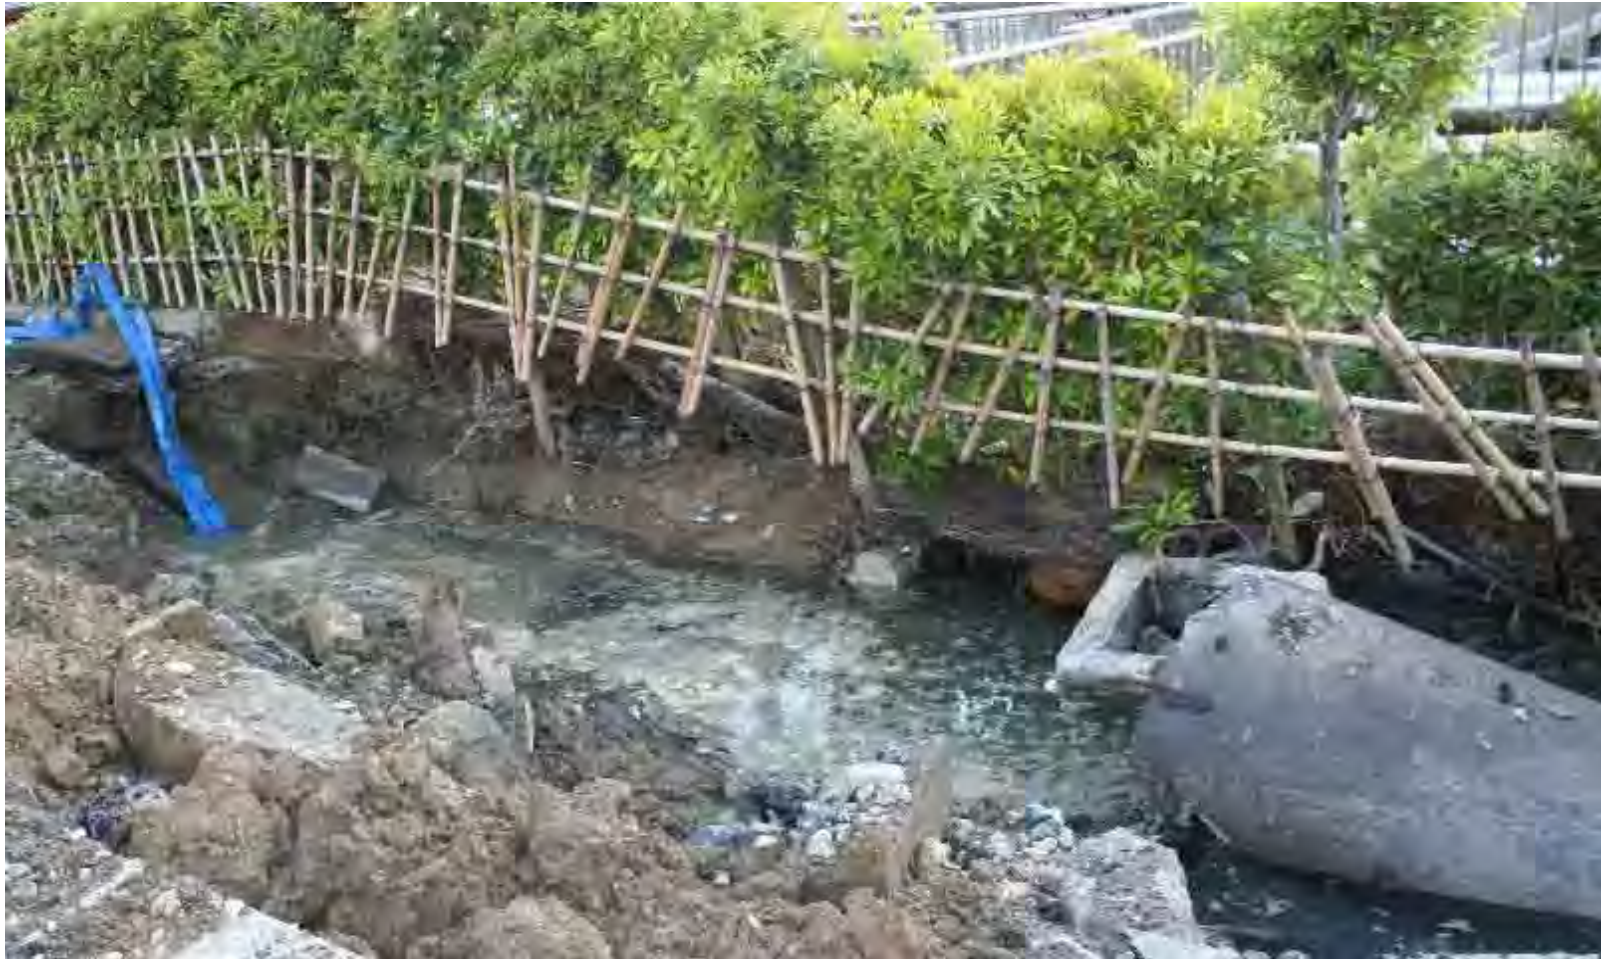
## 4-14 Water Leakage in Okayama-shi in 2007

Damaged pipe and road

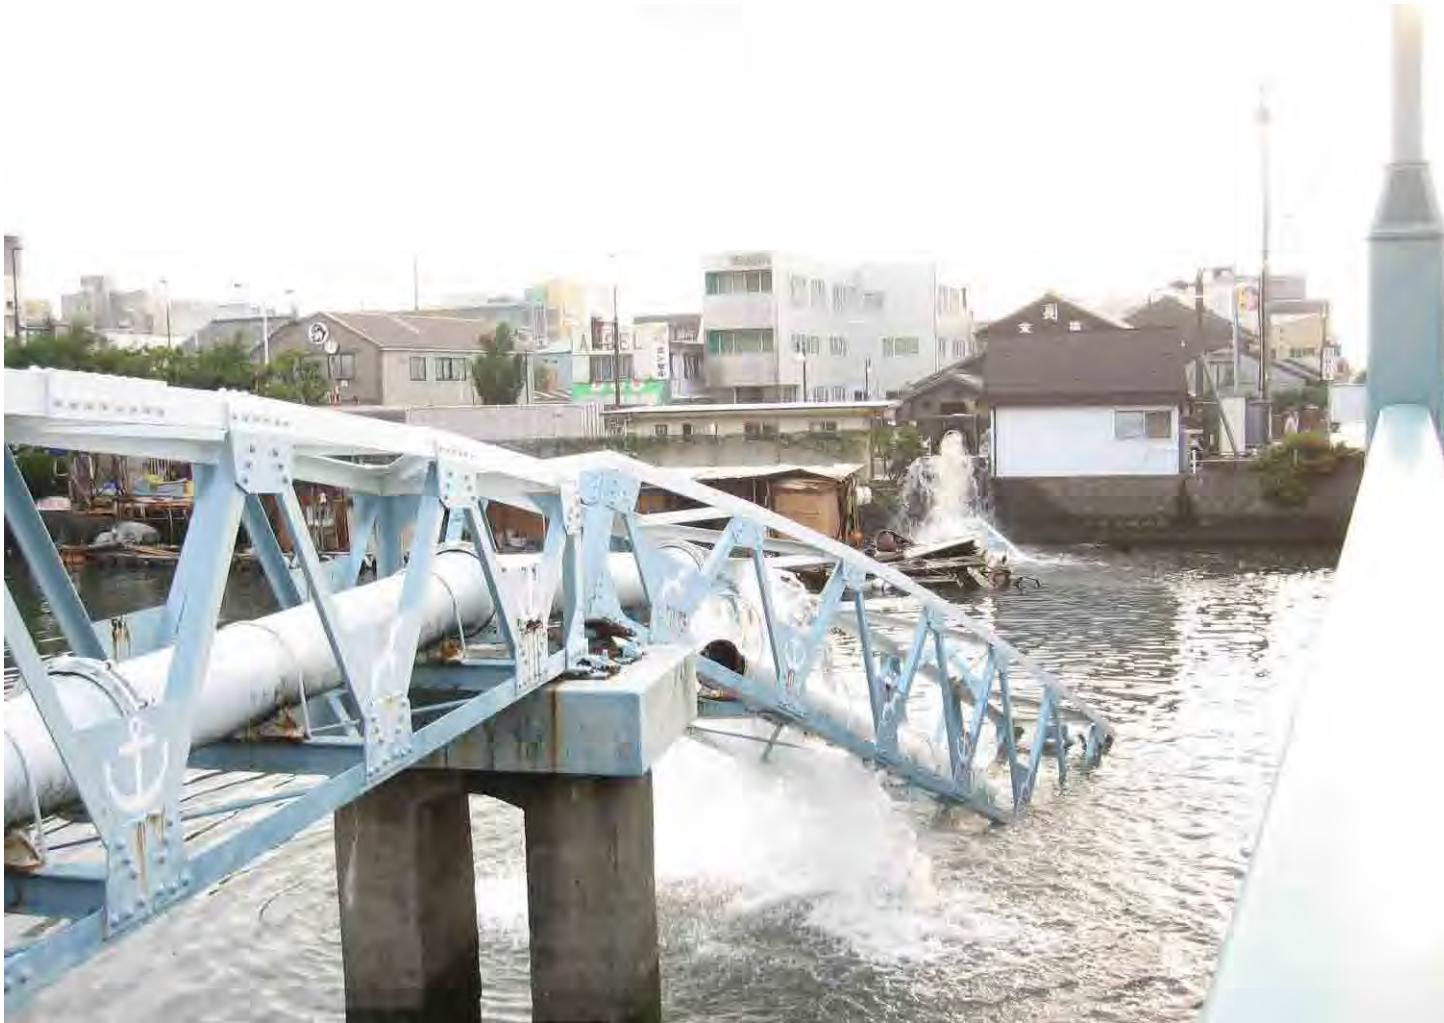
## 4-16 Collapse of a Viaduct in Shizuoka-shi, 2006

- Reported at 4:40 a.m. on July 4, 2006
  - The bridge fell at 4:30 a.m. on July 4, 2006 (recorded in water supply data)
  - Name of the bridge Minatomachi 1-chome Suikankyo
  - Name of the river Tomoe River (grade 2)
  - Year of construction 1931 (early period of the Shimizu era)
  - Pipe type Cast iron pipe (CIP)
  - Diameter 400 millimeters
  - Extension of the bridge 55 meters
  - Structure of the bridge Steel-frame truss bridge with two piers
-

The bridge was damaged.

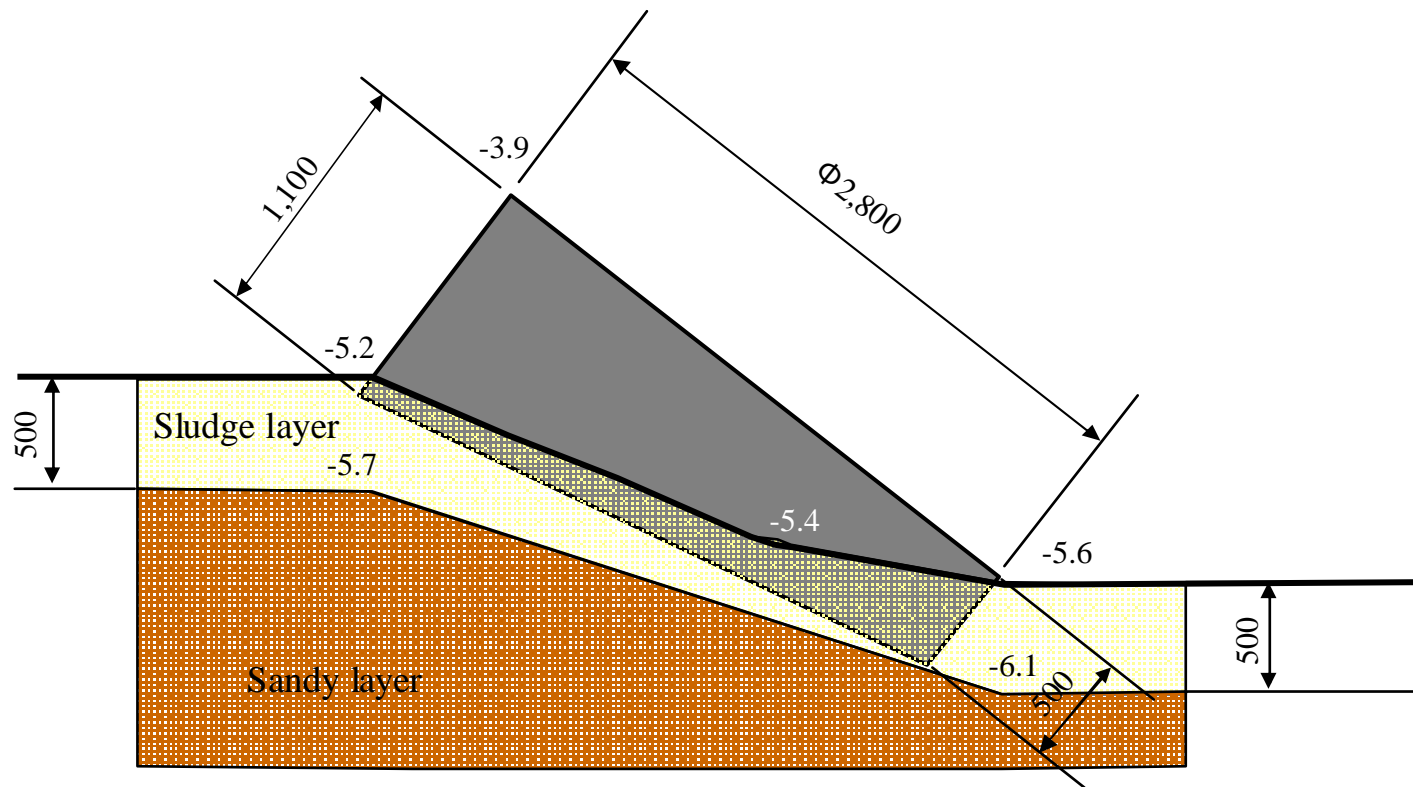
## 4-17 Collapse of a Viaduct in Shizuoka-shi in 2006

Detailed illustration of the remaining part of the pier on the left bank

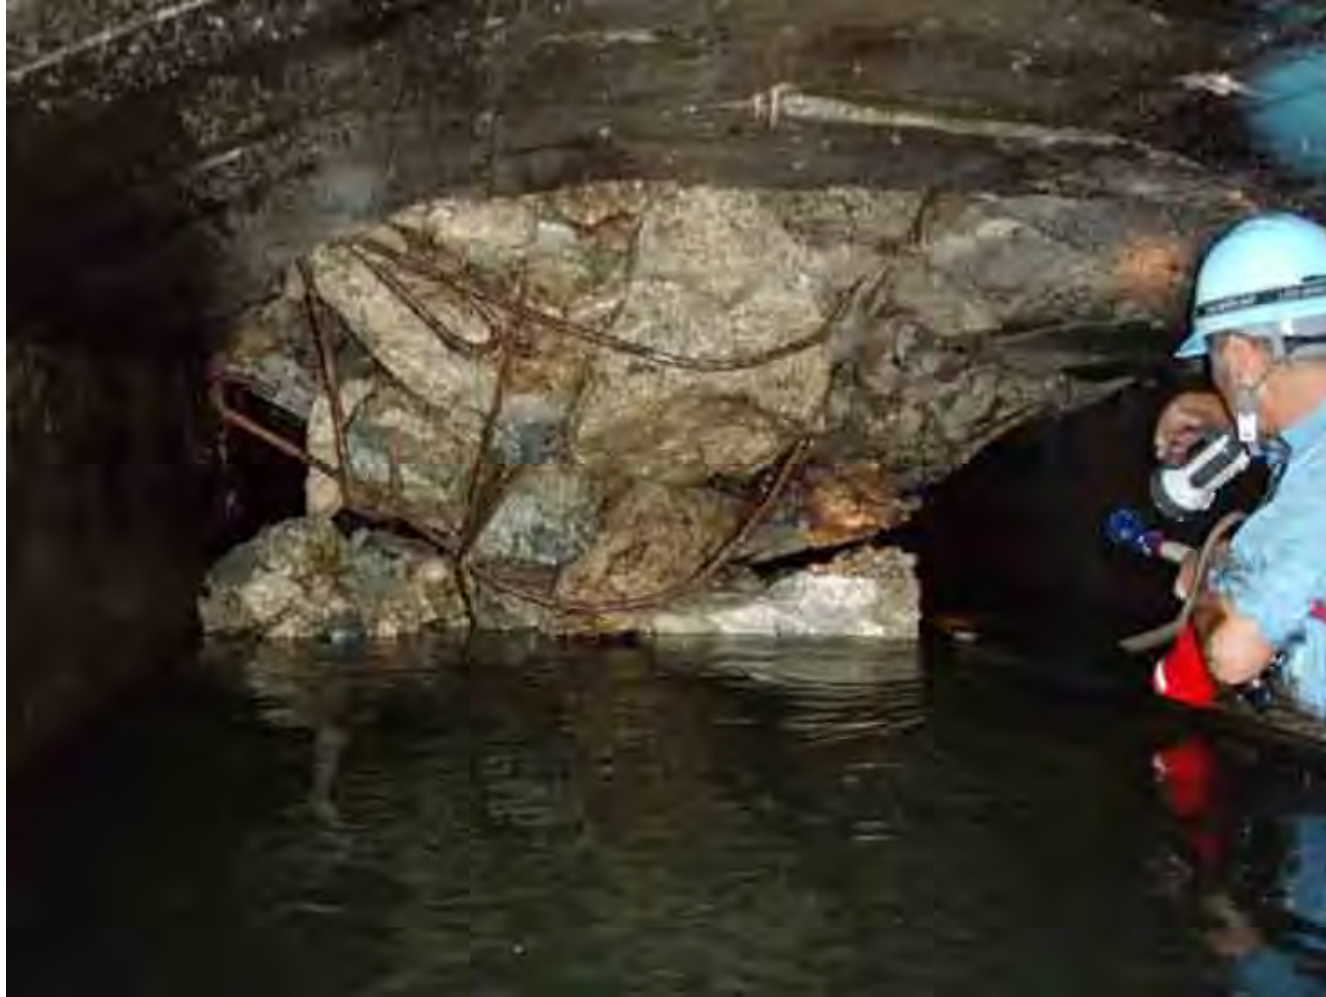
## 4-19 A Caved-in Water Supply Tunnel in Hiroshima, 2006

- Date: Friday, August 25, 2006
- Place: In a 2.9-kilometer water supply tunnel between Kaitacho, Aki-gun and Aki-ku, Hiroshima-shi
- Cause: Bedrock and suchlike caved in and blocked the inside of the water supply tunnel (L = 10.5 meters)
- Restoration: Construction was completed on Monday, September 11, 2006 and water began to flow through the tunnel again on the same day.

Bedrock caved into the tunnel.

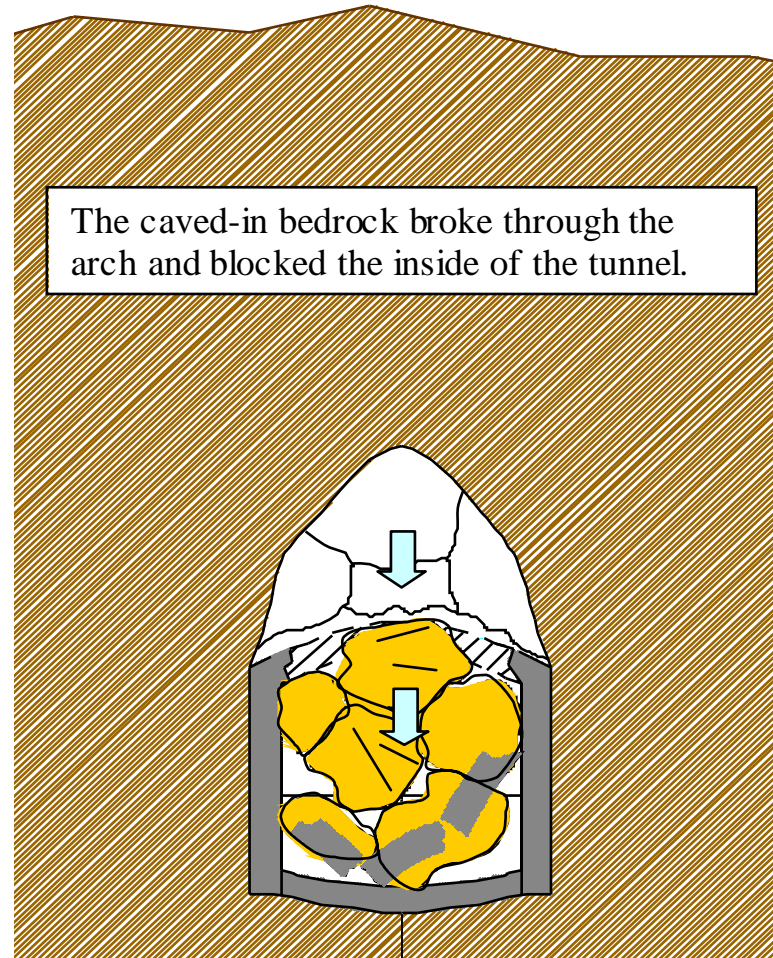
## 4-20 Caved-in Water Supply Tunnel in Hiroshima, 2006

How the bedrock caved into the tunnel
