Workshop on Radiation Exposure Control at the TEPCO Holdings'
Fukushima Daiichi Nuclear Power Plant

Radiation Exposure Dose Survey of the Small Rooms on the First Floor of the Reactor Building for Unit 1 of the Fukushima Daiichi Nuclear Power Plant

**Reactor Preventive Maintenance Design Section
Nuclear Equipment Design Dept.
Hitachi-GE Nuclear Energy, Ltd.**

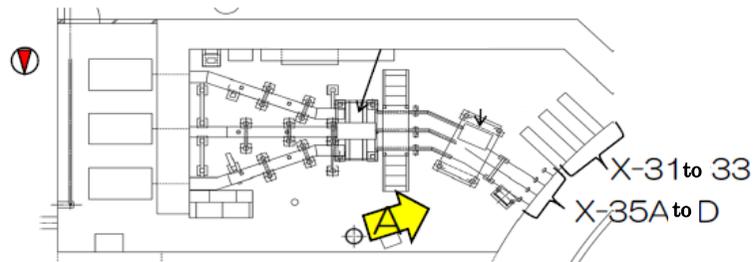
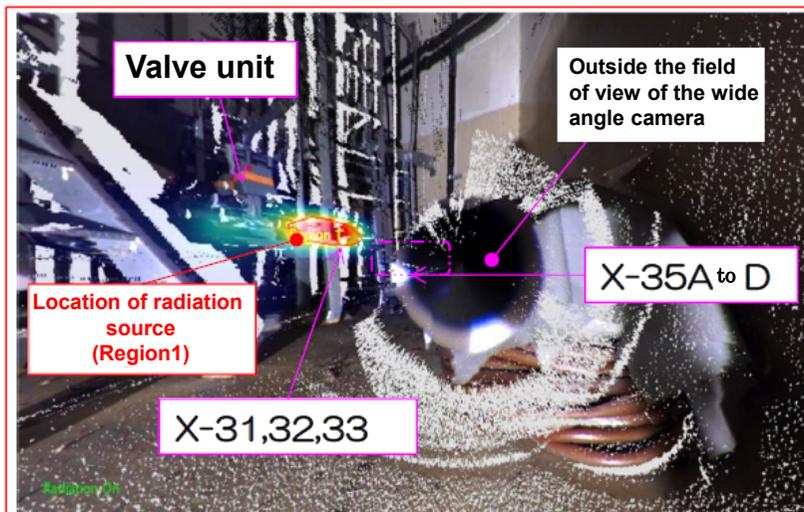
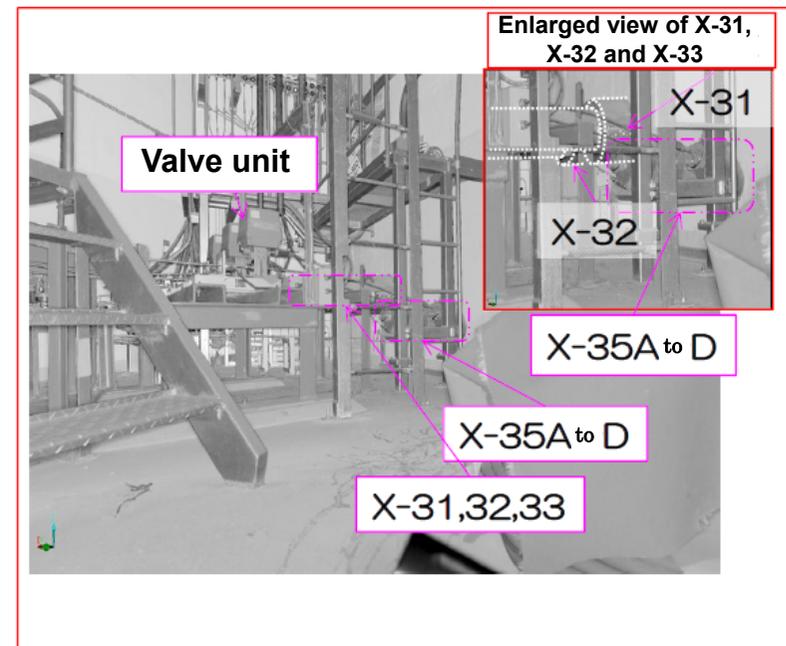
- Radiation sources were identified near the instrumentation piping (X-31 to X-33) by observation in the A direction (arrow).

- Dose rate in the atmosphere at the location of the γ camera: approx. 3.8 mSv/h
- Contribution from the location of the radiation source: approx. 0.2 mSv/h (Region 1)
- No significant radiation source was found in the other areas.

- By combining the γ camera data and the 3D scanning data, it was confirmed that X-31 to X-33 were highly likely to be radiation sources.

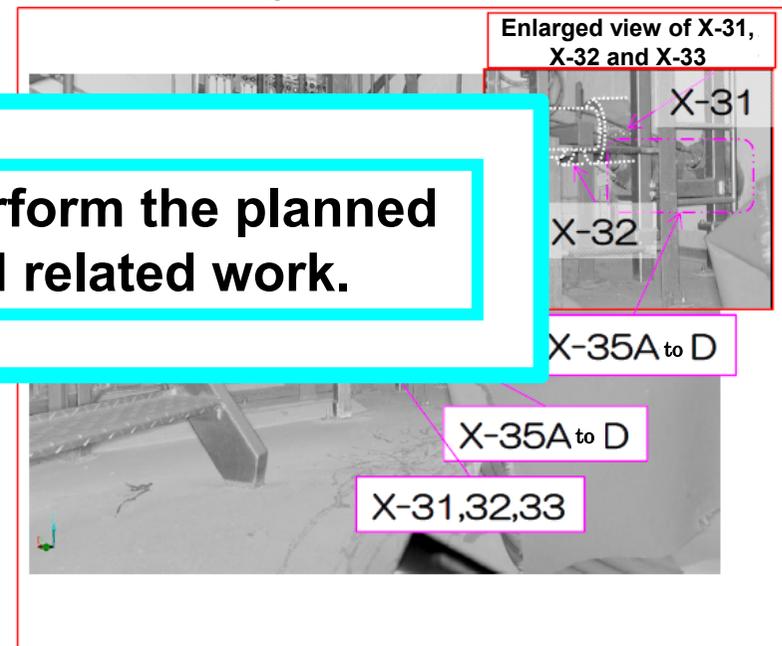
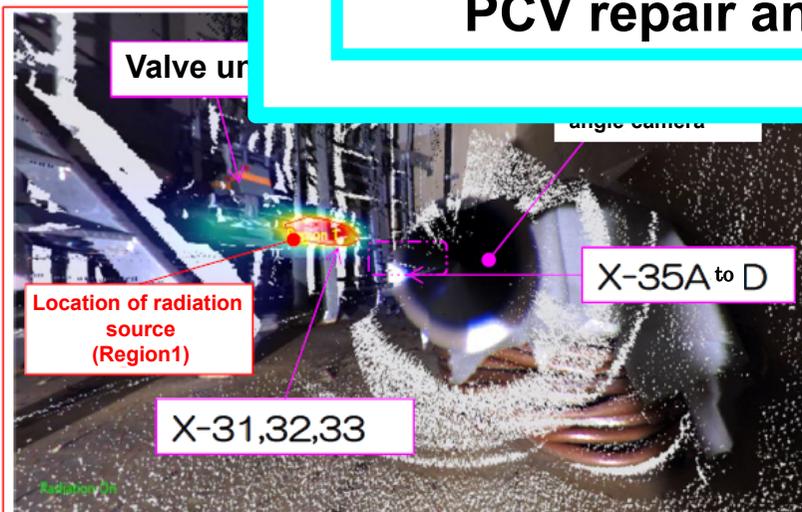
- Radiation sources were identified near the instrumentation piping (X-31 to X-33) by observation in the A direction (arrow).

It is possible to perform the planned PCV repair and related work.

- Dose rate in the atmosphere at the location of the γ camera: approx. 3.8 mSv/h
- Contribution from the location of the radiation source: approx. 0.2 mSv/h (Region 1)
- No significant radiation source was found in the other areas.

- By combining the γ camera data and the 3D scanning data, it was confirmed that X-31 to X-33 were highly likely to be radiation sources.

- The surveys were successfully completed without having workers approach high dose areas.
- Survey of the TIP room
Dose rates in the east side area of the room were relatively low, which indicated the possibility to perform the planned PCV repair and other tasks.

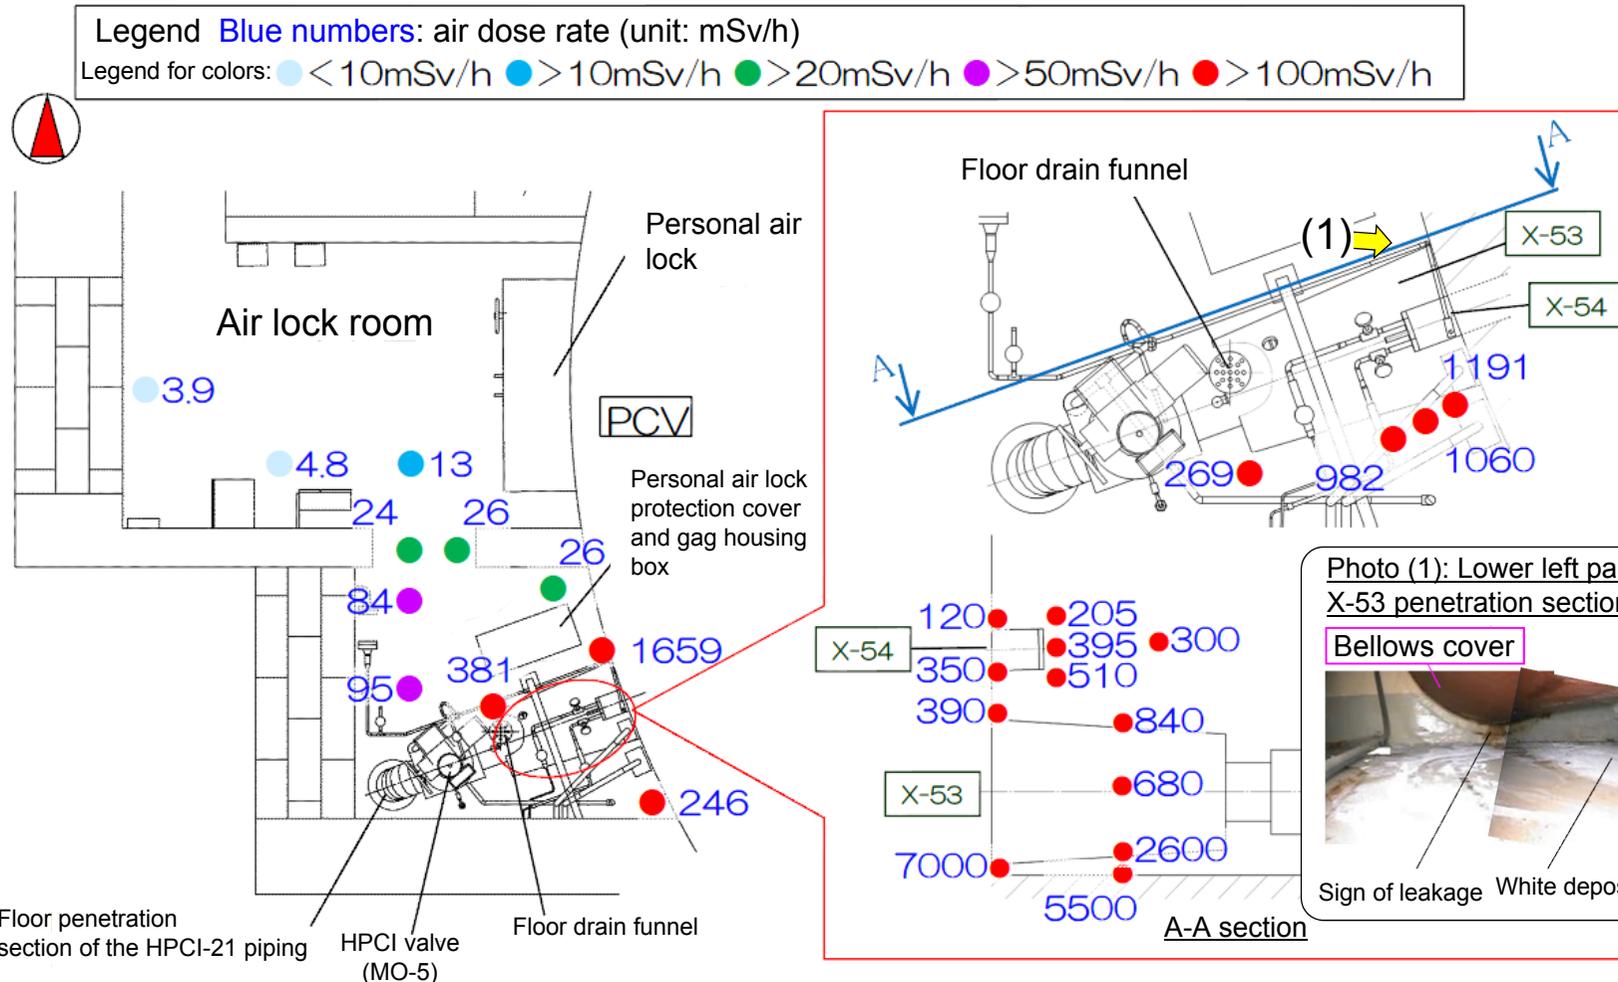
- Dose rate measurements were very high (7000 mSv/h) near the root of X-53 (floor surface).

- Survey of the HPCI valve room
Dose rates at the root of the HPCI piping and in the area around the root were high (7000 mSv/h), which indicated that it is necessary to start studying dose reduction methods for the root and the area around it.

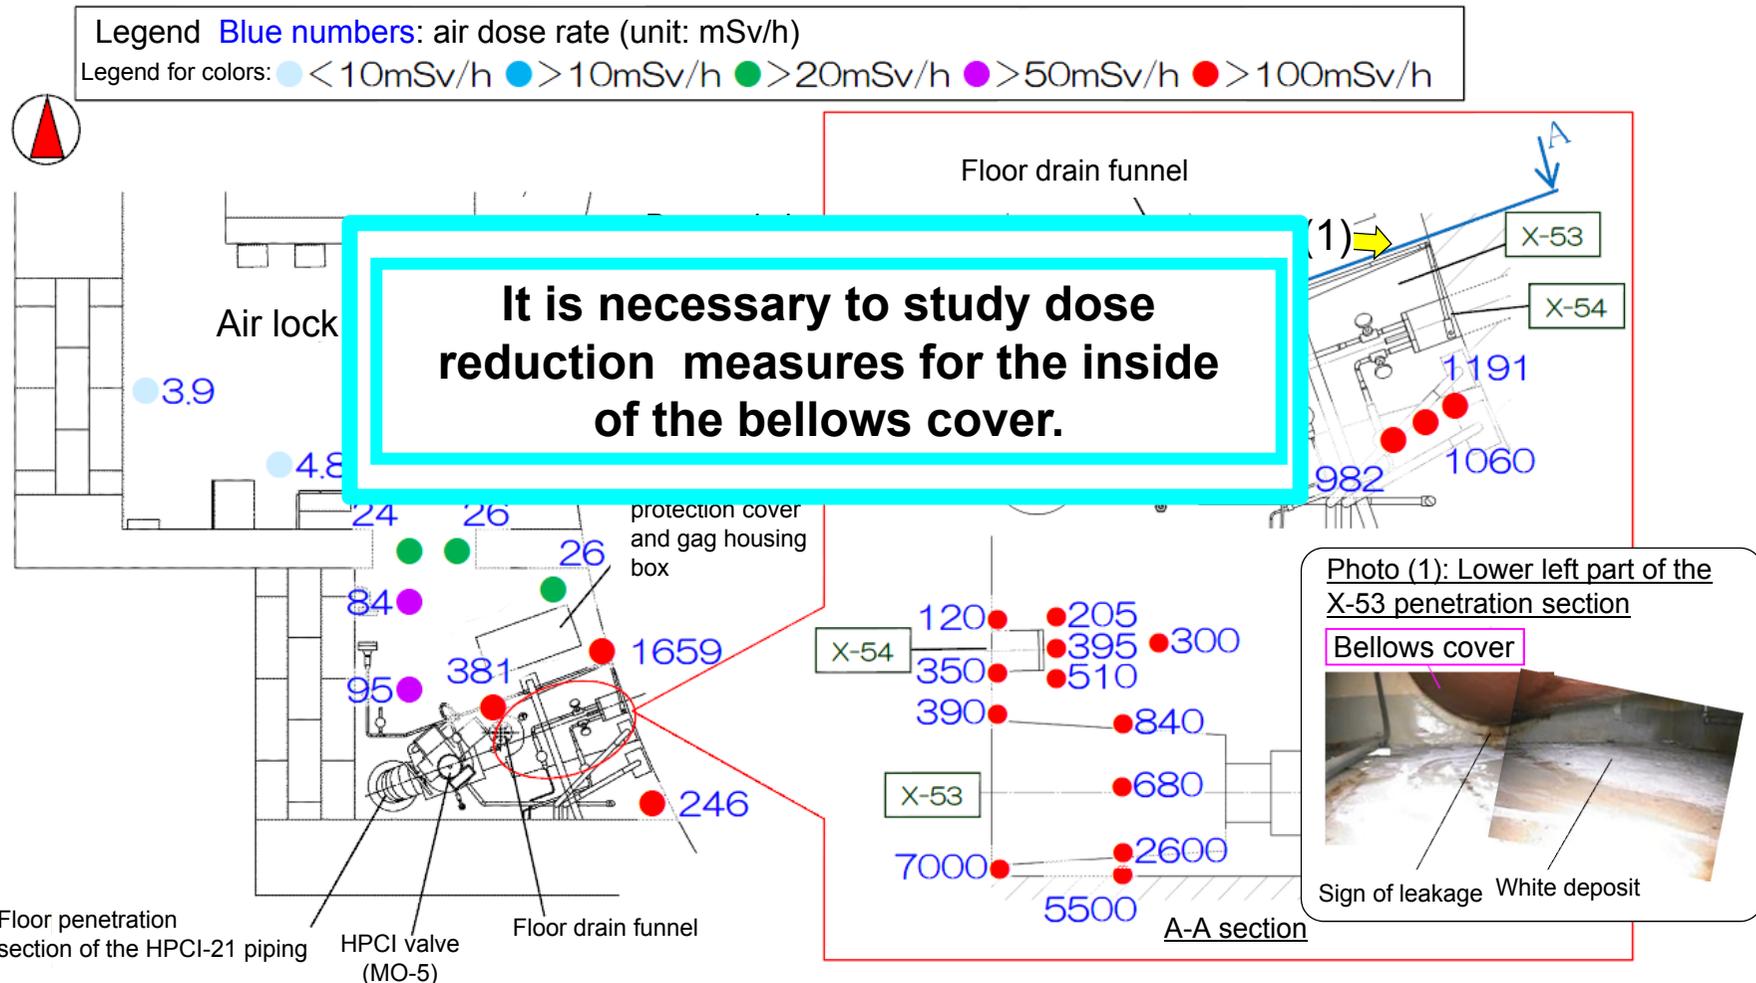
- Dose rate measurements were very high (7000 mSv/h) near the root of X-53 (floor surface).

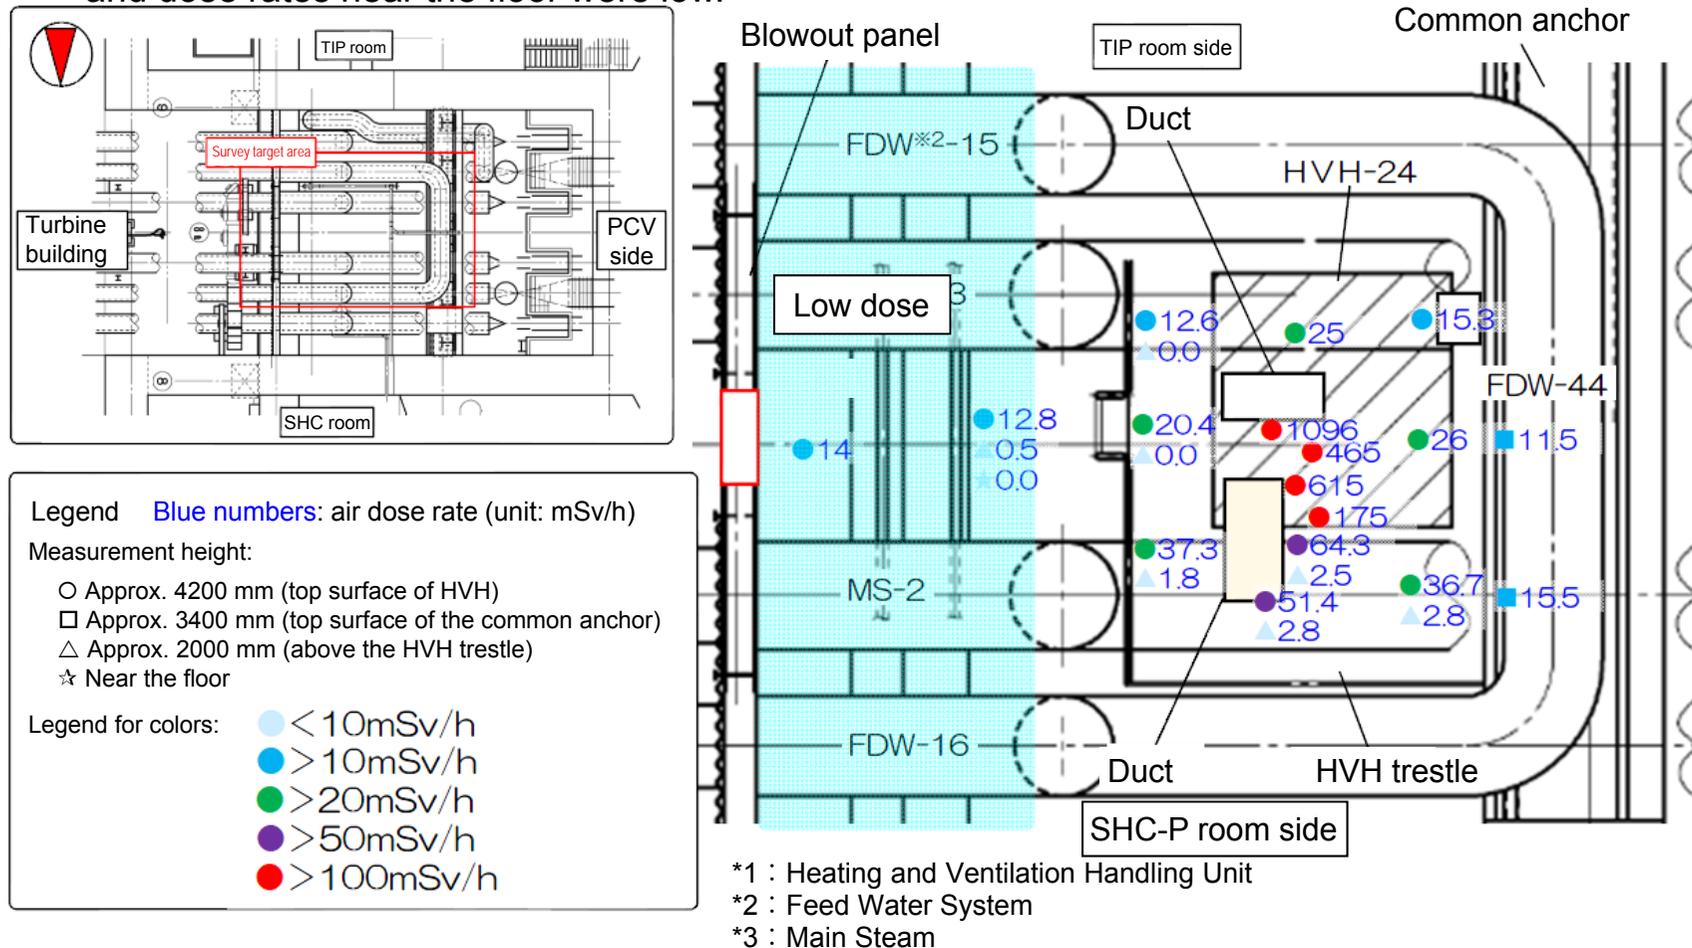
- Dose rates around the HVH* top plate and the duct were high, while dose rates above the HVH trestle and dose rates near the floor were low.

- Survey of the MSIV room
Dose rates in the east passage in the room were relatively low, which indicated the possibility to survey the adjacent SHC-P room.

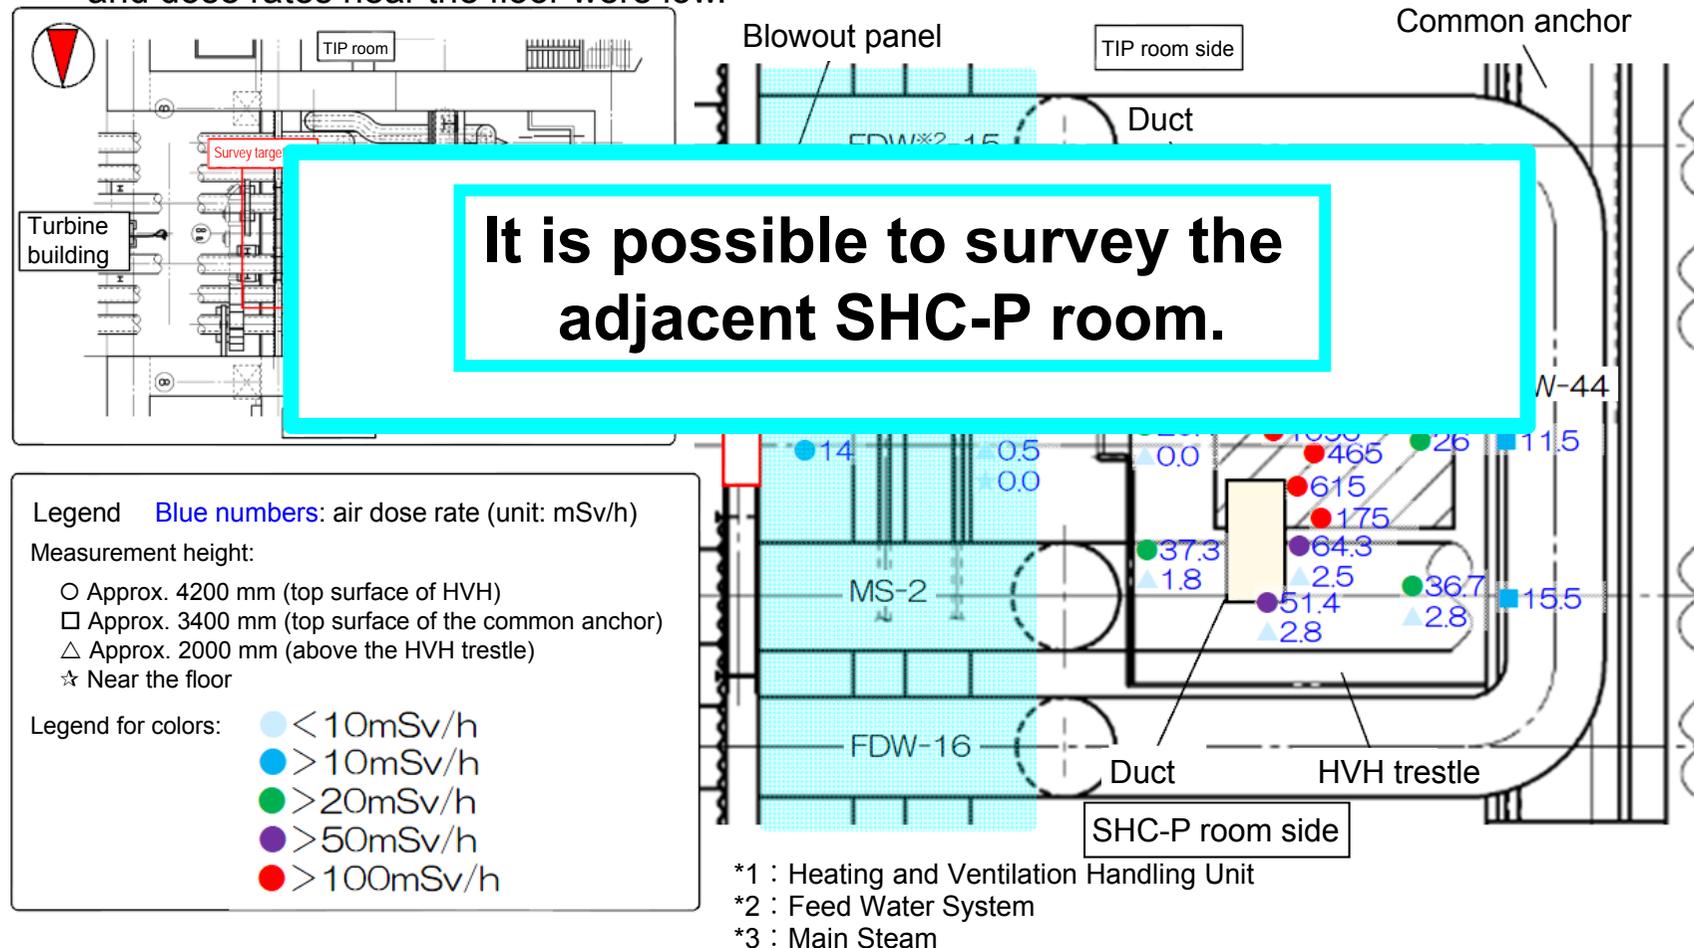
- Dose rates around the HVH* top plate and the duct were high, while dose rates above the HVH trestle and dose rates near the floor were low.
