**Report on the Government-requested Investigation on  
Respiratory Protective Equipment Fitting at the TEPCO  
Fukushima Daiichi Nuclear Plant Stabilization Center  
(J-Village)**

**October 2011**

**National Institute of Occupational Safety and Health, Japan**

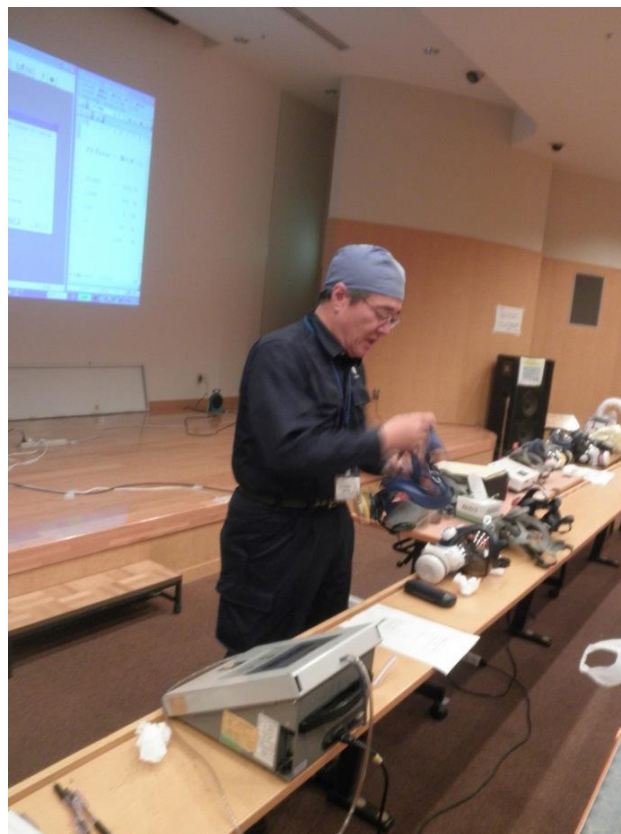
Photo 2 Demonstration by an expert from the Institute. He first explained the intention of the investigation, actually conducted a fitting test and showed the real time leak rate change that occurred according to movement of the body, etc. on the screen in back of him. The device circled in red is the Mask Fitter Tester – MT-03.

Next, a demonstration<sup>2)</sup> on how to wear a respirator was provided to the subjects using a real time counter (Portacount<sup>®</sup> Model 8020 manufactured by TSI) to help their understanding of the causes and the degrees of leakage and to provide instructions on methods for preventing the leak (Photo 2).

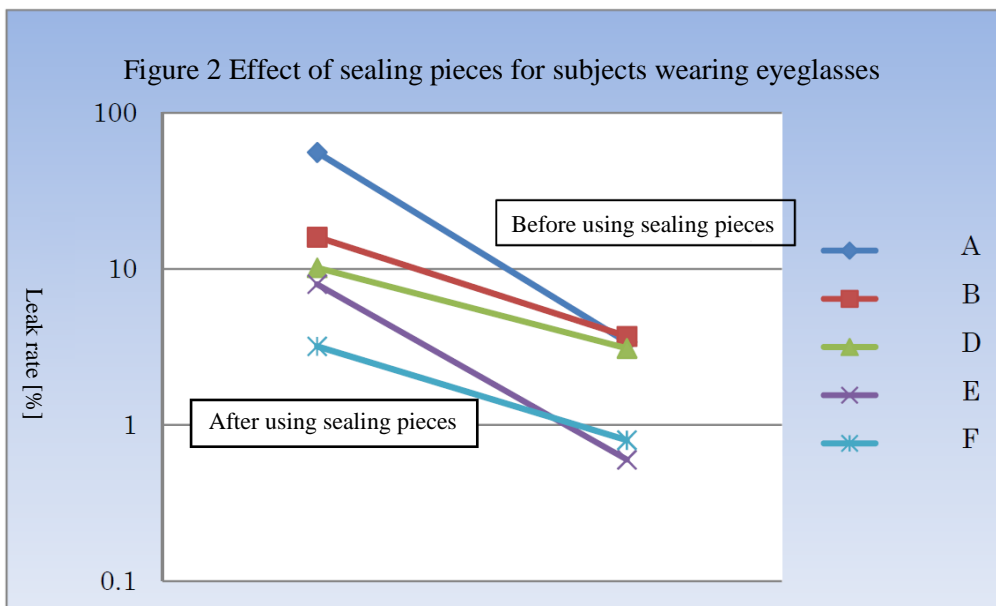
Table 2 Decrease of the leak rates after five subjects used the sealing pieces

The leak rates changed when using the purpose-made sealing pieces (a rubber packing attached to the frame of the eyeglasses; Photo 3). This filled gaps between the mask and the temple for the five subjects wearing eyeglasses. The results are shown in Figure 2 and Table 2. All five workers demonstrated the effectiveness of the sealing pieces (the decrease of leak rates), and the rate decreased to less than 5 % (Photo 4).

Subjects	Leak rates (before use)	Leak rates (after use)
A	56.0 %	3.4%
B	16.0%	3.7%
D	10.2%	3.1%
E	8.0%	0.6%
F	3.2%	0.8%

- ii) Effect of eyeglasses and the change of the leak rate by using sealing pieces: Wearing eyeglasses tended to increase the leak rate when wearing a full-face mask. This trend depended on the shapes and sizes of the eyeglasses. However, when purpose-made sealing pieces were attached to the eyeglass frame, the leak rate decreased. Also, when the mask was well fitted to the face, it was possible to keep the rate at 5 % or less even wearing eyeglasses without sealing pieces.

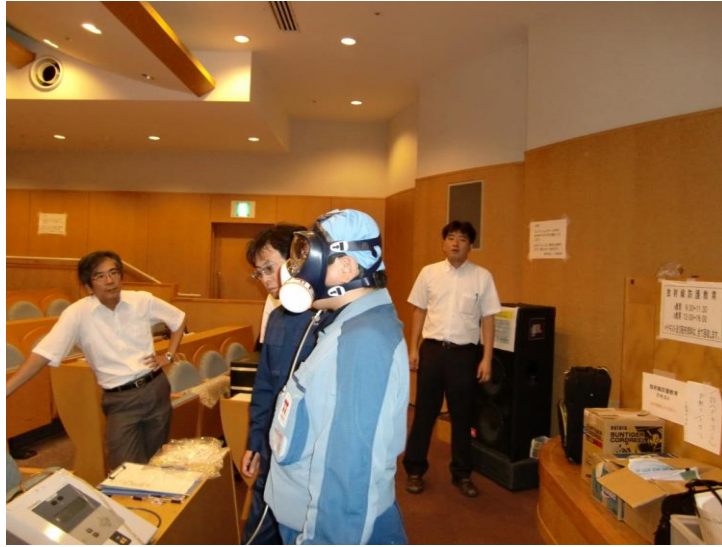
Photo 4 Re-testing the fitting after a subject attached sealing pieces to his eyeglasses.

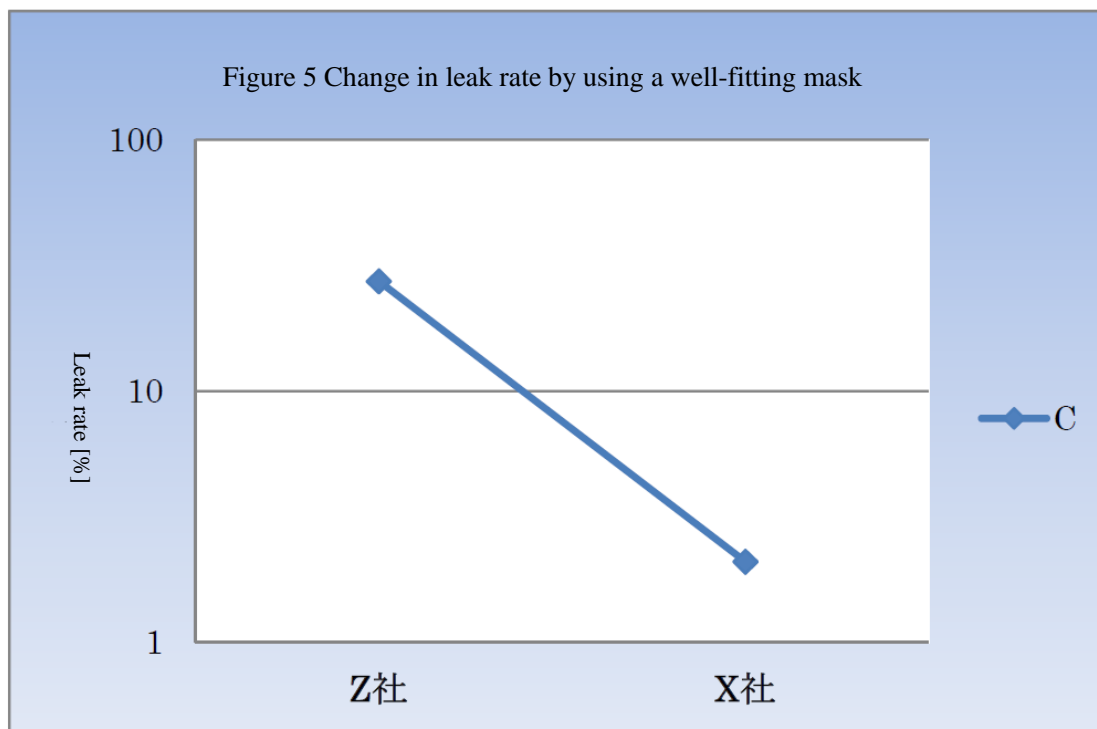
Table 5 Decrease in leak rate by using a better fitting a mask

For one subject who felt uncomfortable with respect to contact of the mask on his face, the change in leak rate was determined by having him wear a mask manufactured by a different company. The changes of the leak rates are shown in Figure 5 and Table 5. In the figure, manufacturer Z is for his previous mask, and manufacturer X is for the new mask.

Subject	Leak rate: poor fit	Leak rate: good fit	Remarks
C	27.4%	2.1%	The leak rate change depended on the mask fit to the subject's face shape. This does not mean lesser performance of the previously used mask.

- vii) Decrease of the leak rate by selecting a better fitting mask: Masks unsuitable to the facial shapes and sizes caused significant air leakage. The leak rate could be significantly decreased by using a mask that fit the face well.

For recommendation (2), the selection of well-fitting masks will prevent leakage caused by a mismatch between the facial size and shape (contours) and the mask size. In this fitting test, it was confirmed that the leak rate decreased by changing one full-face mask to a better fitting one. It is recommended that TEPCO prepare masks in various sizes so that workers are able to choose the one which well fits the shapes and sizes of their faces. At J-Village, large numbers of masks are provided. However, their sizes are not indicated. By grouping masks by size, workers can be expected to easily select one which fits them well.

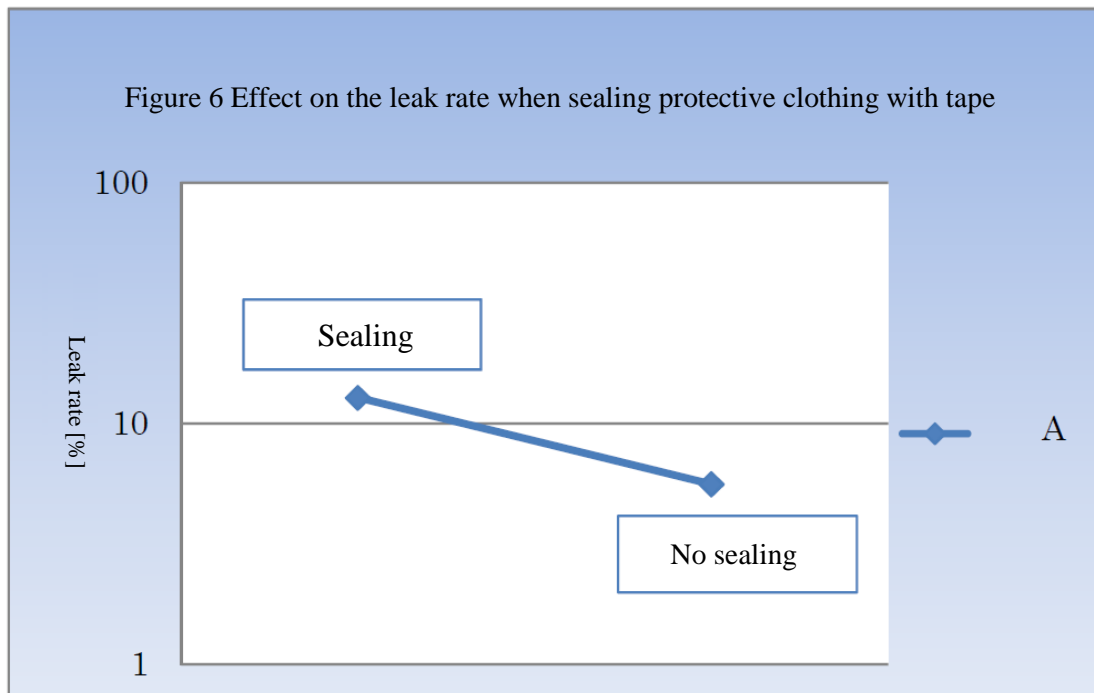
Table 6 Decrease in leak rate by sealing protective clothing with tape

One subject was selected to investigate the effect on the leak rate when using sticky tape to seal the mask to his protective clothing (Tyvek® SoftWear). The result is shown in Figure 6 and Table 6.

Subject	No Sealing	Sealing	Remarks
A	12.8%	5.6%	Protective clothing (Tyvek® SoftWear) worn. Eyeglasses without sealing pieces worn. Full-face mask (Company X) worn.

- ix) Effect of tape sealing to protective clothing: Tape sealing the mask to the protective clothing contributed to lowering the leak rate. However, only one subject was measured for this effect, and further tests are required before reaching the final conclusion.
