Workshop on Radiation Exposure Control at the TEPCO Holdings'
Fukushima Daiichi Nuclear Power Plant

Radiation Exposure Dose Survey of the Small Rooms on the First Floor of the Reactor Building for Unit 1 of the Fukushima Daiichi Nuclear Power Plant

**Reactor Preventive Maintenance Design Section
Nuclear Equipment Design Dept.
Hitachi-GE Nuclear Energy, Ltd.**

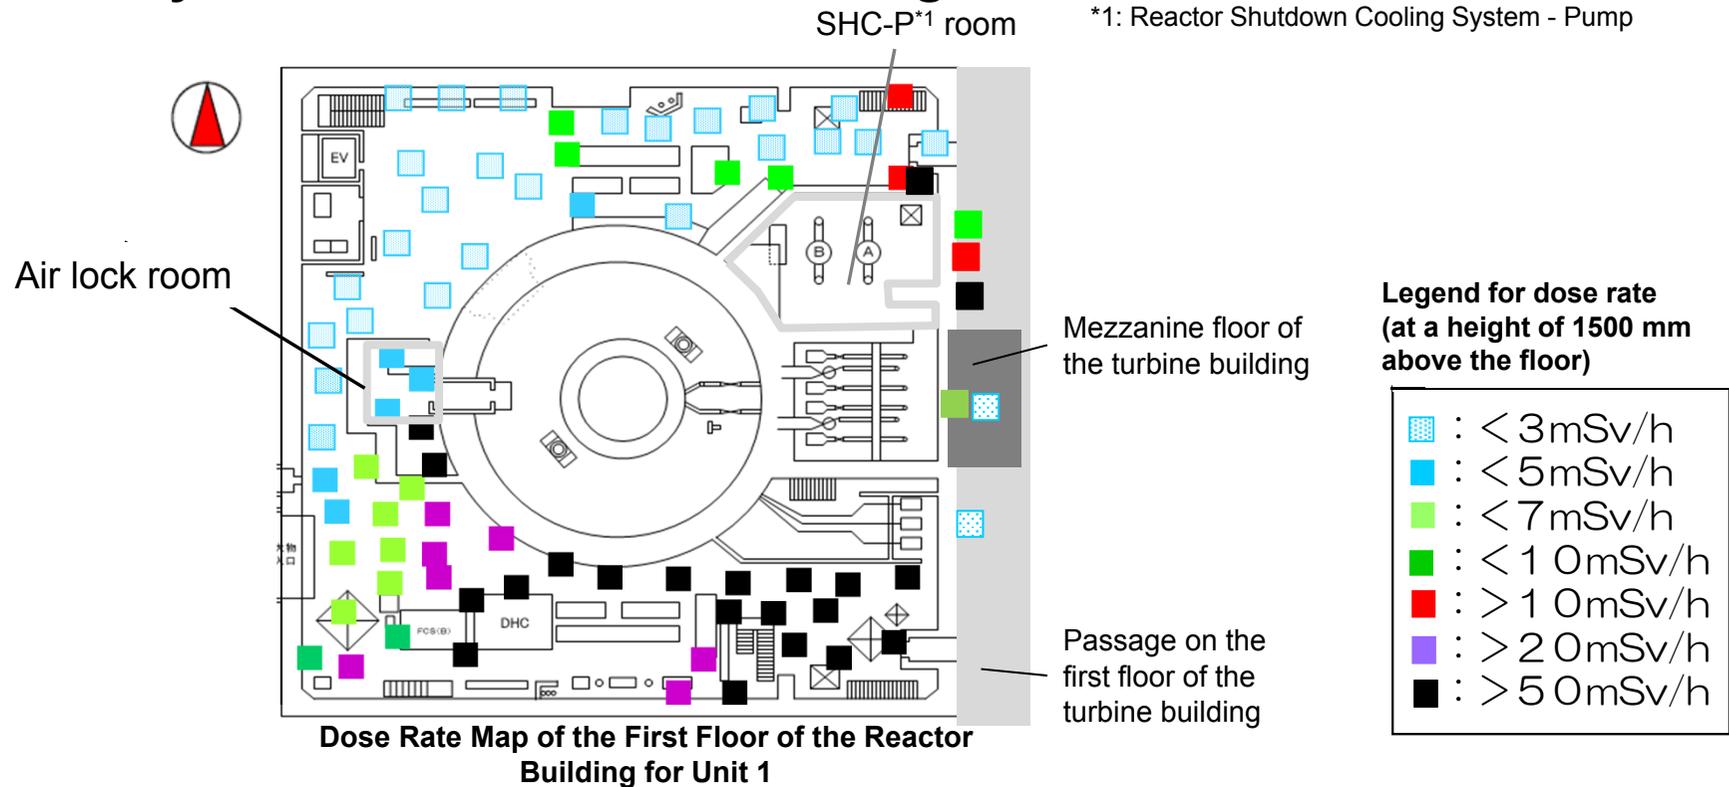
Area	Status of survey
North side	Relatively low dose area. Survey by human workers has already been conducted.
South side	High dose area. A remotely-operated robot-based survey has already been conducted.
Small rooms	The HPCI valve room, TIP room, MSIV room and SHC-P room have not been surveyed yet.

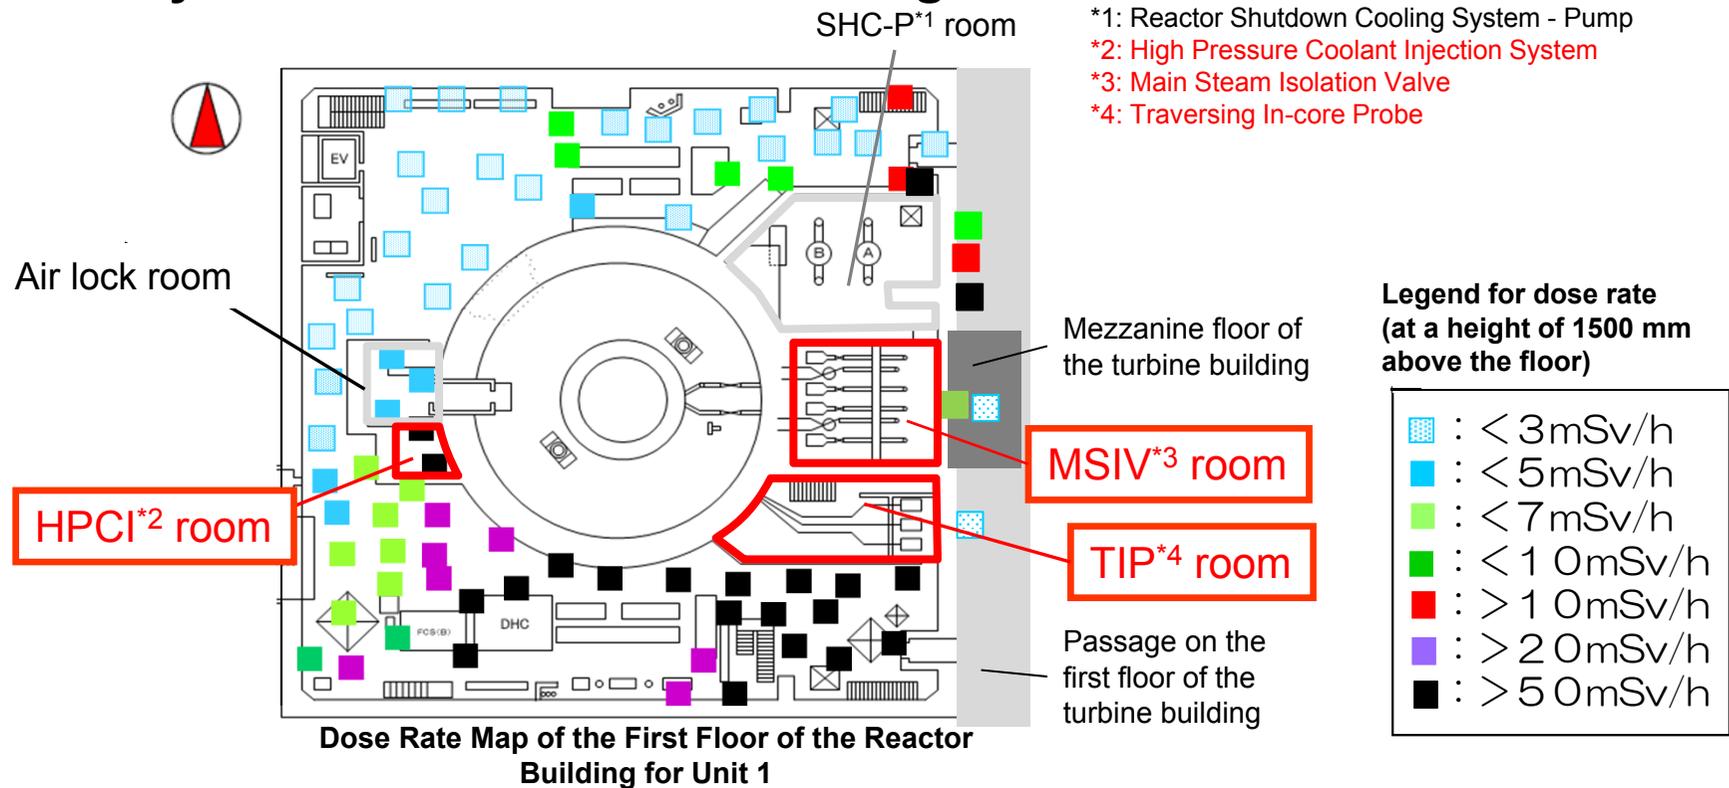
Area	Status of survey
North side	Relatively low dose area. Survey by human workers has already been conducted.
South side	High dose area. A remotely-operated robot-based survey has already been conducted.
Small rooms	The HPCI valve room, TIP room, MSIV room and SHC-P room have not been surveyed yet.

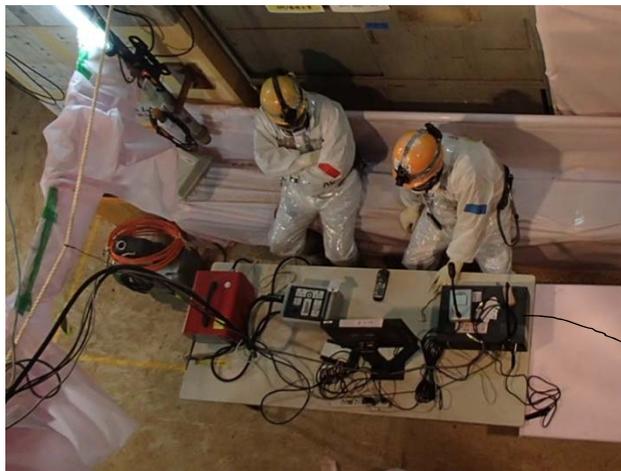
The robot is remotely operated by workers from a low dose area.

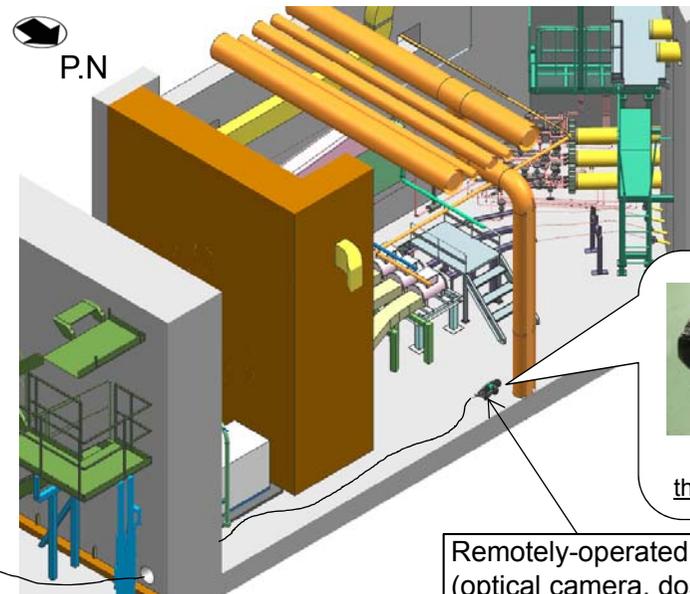
External appearance of the remotely-operated robot

Remotely-operated robot (optical camera, dosimeter)

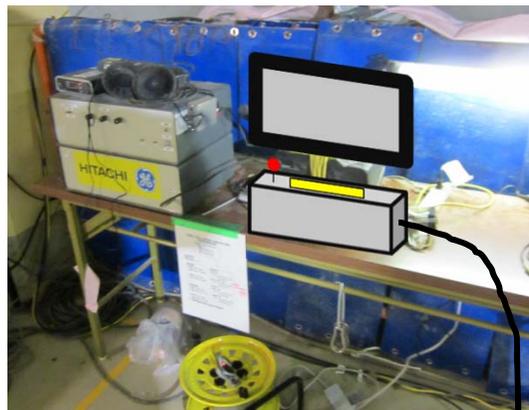
Workers can remotely operate the robot from a low dose area

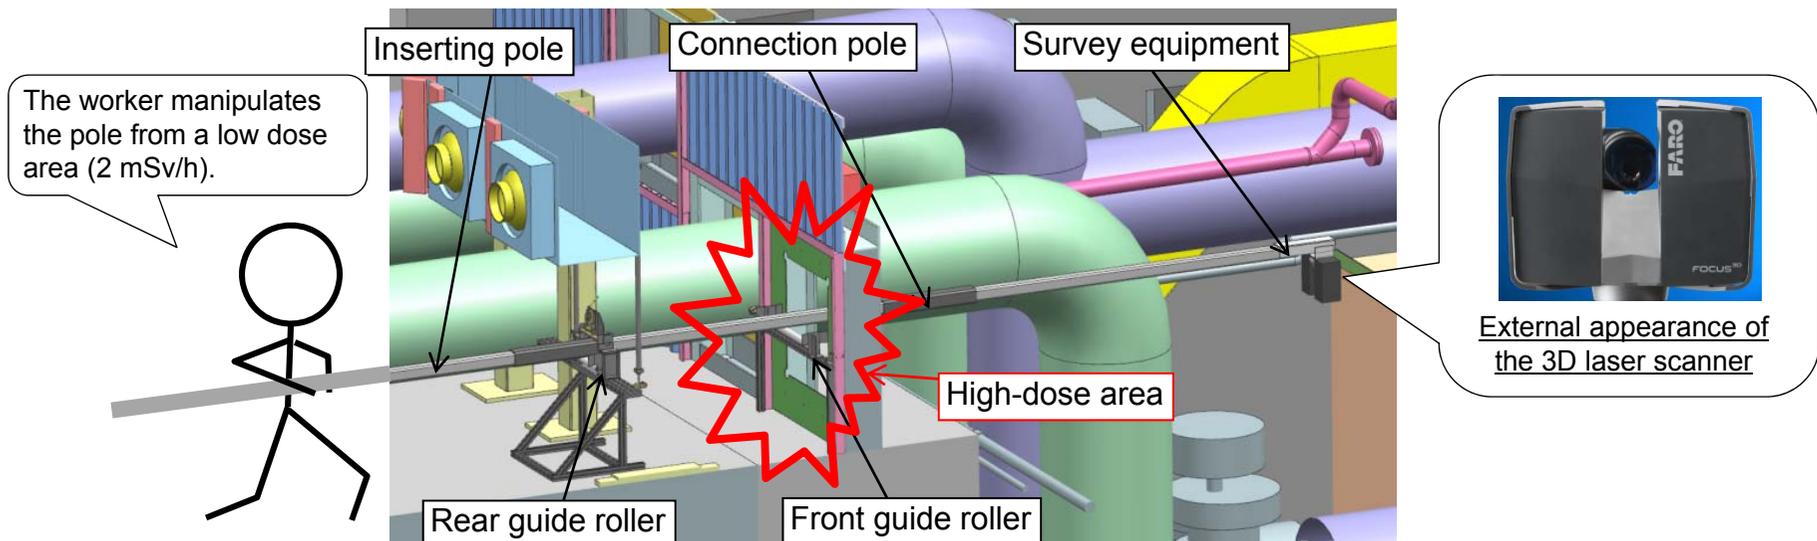
The room is surveyed by inserting a long pole into the room.

- Exposure of the worker is reduced by securing a long distance between the end of the long pole and the high dose entrance.
