**PROJECT TO PROVIDE PLANNING GUIDANCE FOR
THE WATER SUPPLY PROJECT (PHASE-2)**

**PROJECT FOR IMPROVEMENT OF
WATER SUPPLY SYSTEM IN VAVA'U,
THE KINGDOM OF TONGA**

FINAL REPORT

NJS CONSULTANTS CO., LTD.

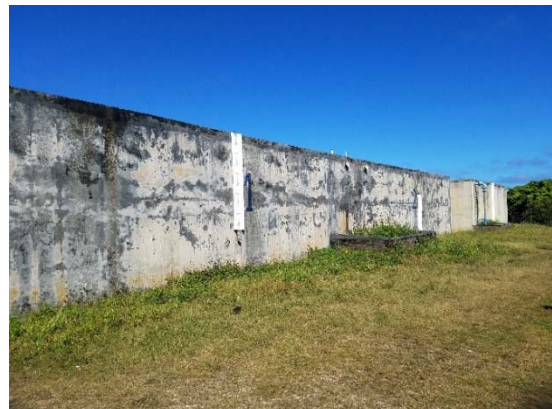
Photo-6: Existing Reservoir (Vava'u)
RC structure of 1,400 m³ (450 m³×2, 500m³×1). Efflorescence at some parts potentially caused by its deterioration was found on the wall surface.

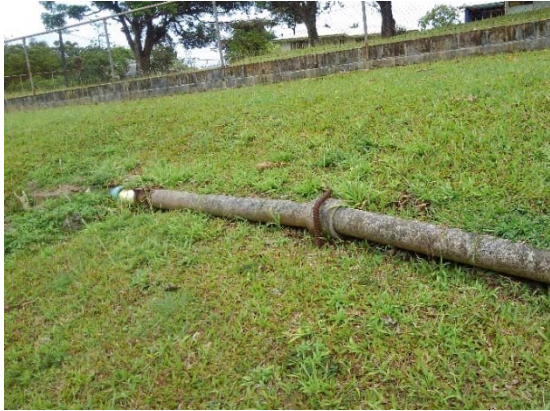
Photo-7: Asbestos Cement Pipe exposed on ground surface

Asbestos Cement pipe of about 4 km extension is still remaining in Vava'u is to be replaced immediately to eliminate the water leakage and its potential impact on human health risk.

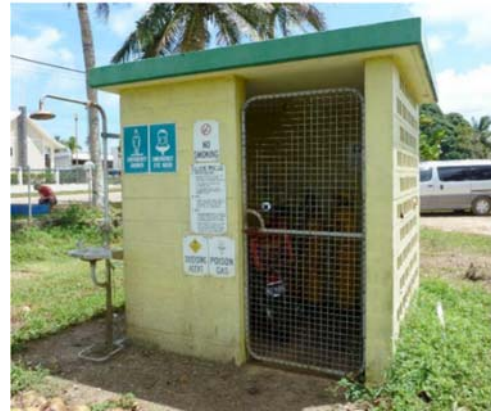
Photo-8: Chlorine Injection Unit (inside existing workshop)

Chlorine gas injection is not carried out because of the difficulty of the procurement of the chlorine gas. Instead, chlorine tablets are added to the extracted water once every morning. However, no residual chlorine is detected in the water at night time.

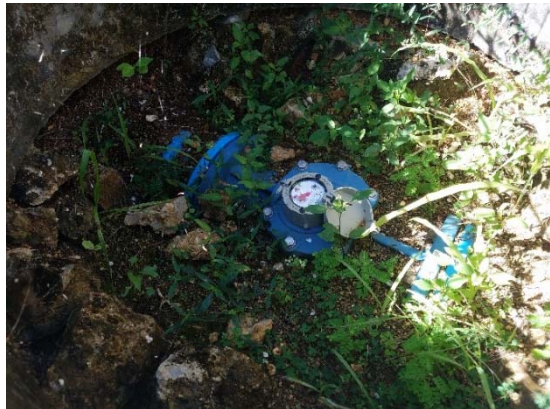
Photo-9: Flow Meter

The flow meter of the existing reservoir is working normally

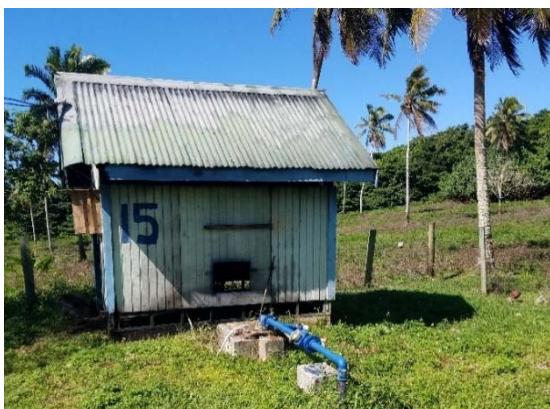
Photo-11: Current Well Field for Water Intake

The extraction pump and its control panel is installed inside the pump house.

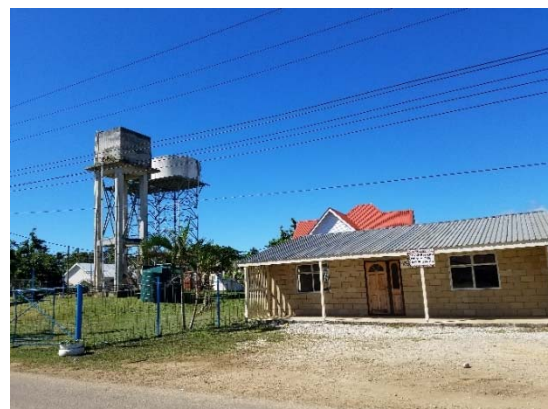
Photo-12: Water Supply Facilities at Rural Areas (1)

The water supply is operated by VWC (Village Water Committee). The facility extracts groundwater and pumped up to the overhead tank and the water is distributed by gravity from the tank.

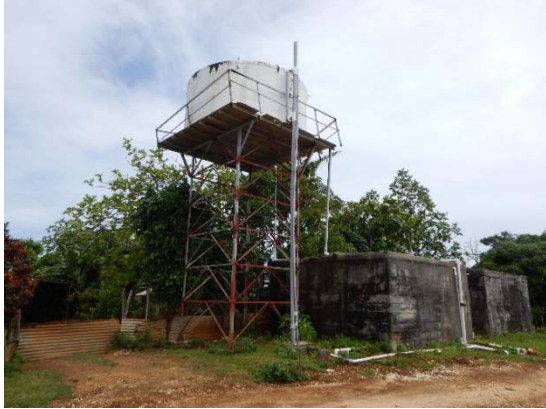
Photo-13: Water Supply Facilities at Rural Areas (2) (Leimatua)

The water is supplied only for three (3) hours without any disinfection by chlorine. Typhoid occurred in autumn in 2019 in the vicinity of Leimatua village.

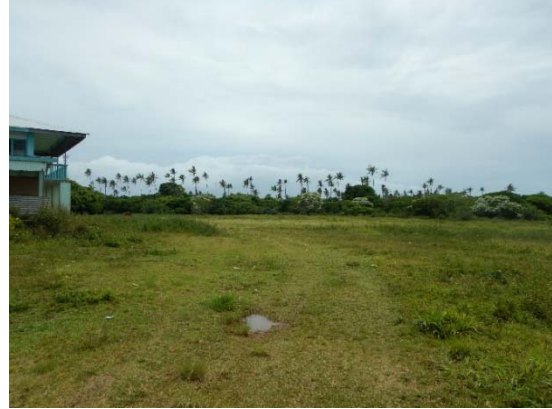
Photo-14: Candidate Site of the Proposed Reservoir (Leimatua)

A wide vacant land is available for the proposed reservoir. The land is located on a hillside where the stored water at the reservoir can be distributed by gravity to the planned supply area.

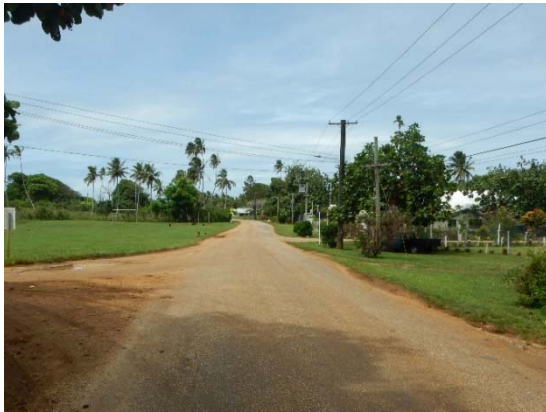
Photo-15: Road Condition at the Project Site

Concrete pavement at the suburb areas. Less traffic compared to the city center.

The pipes will be laid underground of the road that are currently under jurisdiction of MOI (Ministry of Infrastructure). According to the survey team's interview with TWB, the approval for the pipe laying works is easily obtained from MOI. Photo 3.2 shows the current conditions of the road in Vava'u. The main road from the Vava'u International Airport to the city area of Neiafu is currently concrete pavement, whereas the suburb road is paved with concrete mixed including the aggregate originating coral limestone. The roads in Vava'u has low traffic generally, which can cause low impact on these road during the pipe laying works.

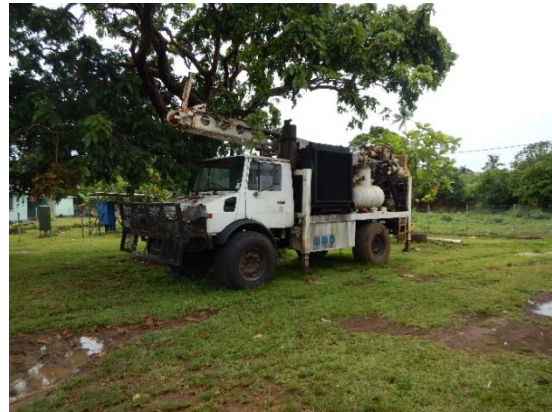
Photo-16: Drilling Rig for Well

TWB owns a drilling rig for well extraction for the ground water that is only one water source in Vava'u.

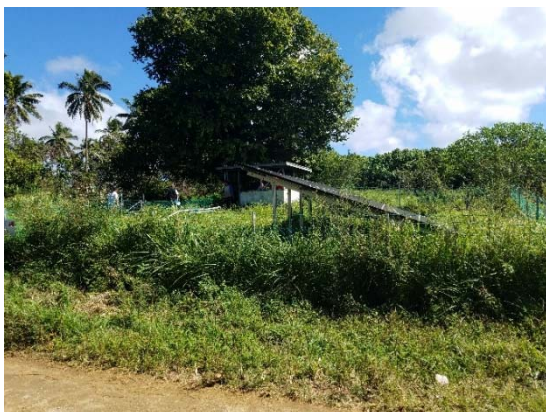
Photo-17: Solar Panel and Pump Unit that was procured by Japan ODA Assistance

Solar Panel and Pump Unit that was procured by Japan ODA Assistance

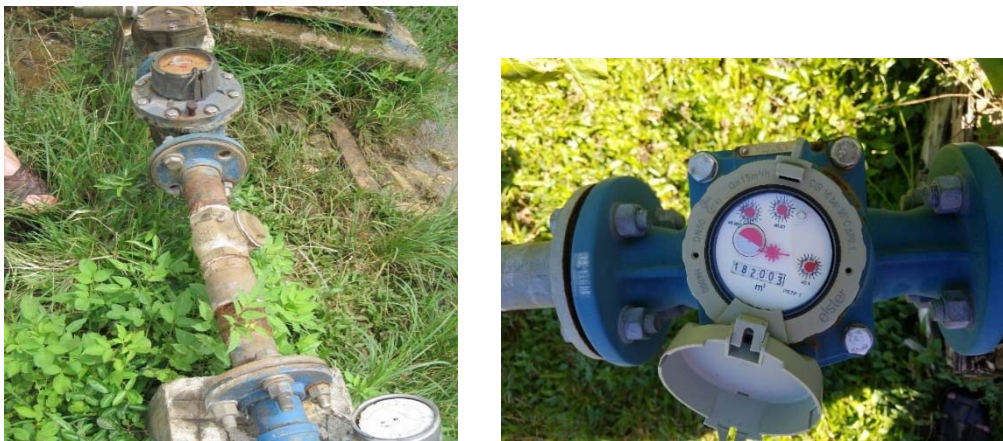
Photo 2.1 Malfunctional Flow Meter

Some flow meters of the intake pumps are malfunctioned and left as they are because no budget is allocated for their repair and renewal (See Photo 2.1). The malfunction has brought an inaccuracy measurement of the intake volume for appropriate flow management. Therefore, improvement through repair or renewal of the equipment is urgently needed for the daily flow management. And to accumulate the daily performance data will provide basic information on the future improvement of the financial management or planning of the future facility plan.

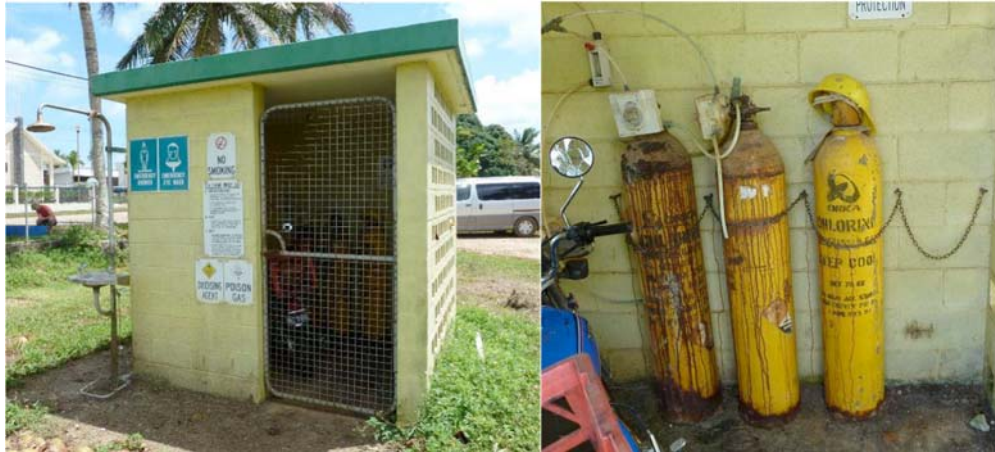
Photo 2.2 Chlorine Injection Unit that is not in Use

Since chlorine gas cannot be procured for the chlorine injection unit, located inside the workshop in the city center of Neiafu, which was installed by the support from the foreign donor, the unit is not used for the actual operation (See Photo 2.2). At present, instead of that, tablet of sodium hypochlorite is thrown into the reservoir once every morning by the operation staffs. The survey team obtained a data of residual chlorine exceeding 0.1 mg/L through their water quality measurement (Pack Test) at daytime (around 2 pm) in December 2019 in Toula village which locates at the southernmost boundary of TWB's supply area. However, the survey team also obtained another data at night time in the city center of Neiafu that no residual chlorine was detected, which showed water is distributed to the consumers without disinfection (See Photo 2.3).

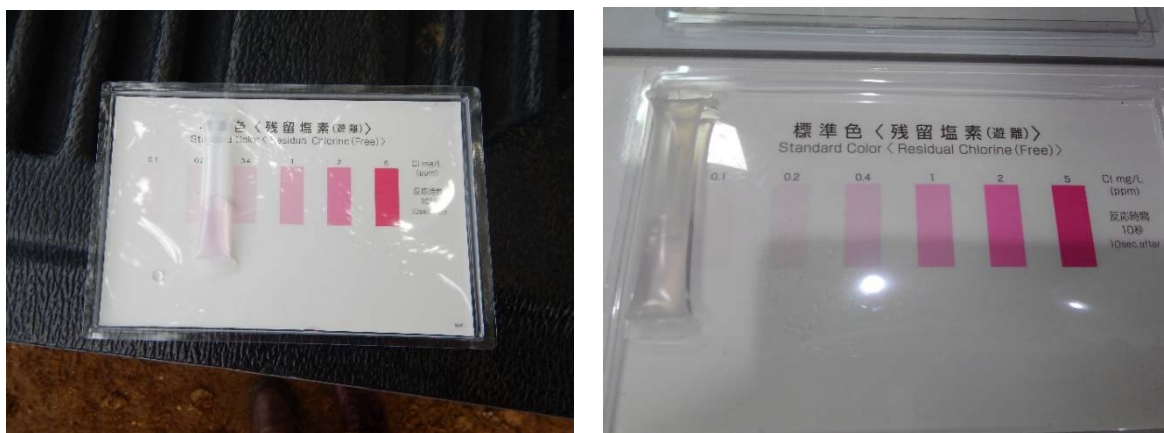
Photo 2.3 Results of Pack Test for Residual Chlorine
Left: At Toula Village (PM 2:00), Right: City Center of Neiafu (PM 10:00)

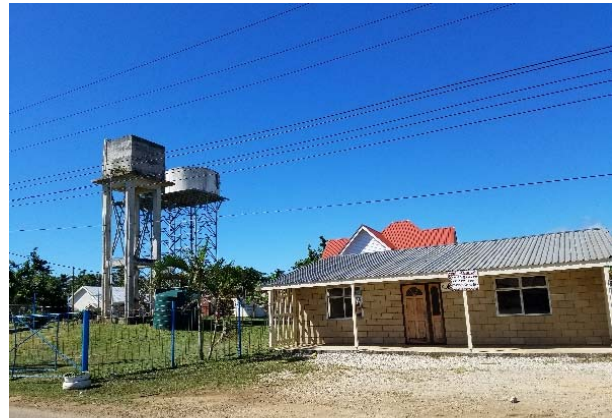
Photo 2.4 Water Supply Facility at Rural Areas

Water supply for schools or households in the rural areas is operated by VWC under the jurisdiction of MOH (See Photo 2.4), which cannot secure enough amount for the water supply service from the intake wells resulting in its operation hours of only for three (3) hours. The water source is concerned to be polluted by the coliform possibly caused by infiltration of some parts of the sewage from the septic tanks into the underground. In addition, the water is distributed to the consumers without any disinfection because the VWC's water supply system doesn't have any disinfection equipment. And it leads to high risk of occurrence of waterborne diseases. Furthermore, the water source in the village areas has another pollution risk to be caused by the use of pesticides or chemical fertilizers.

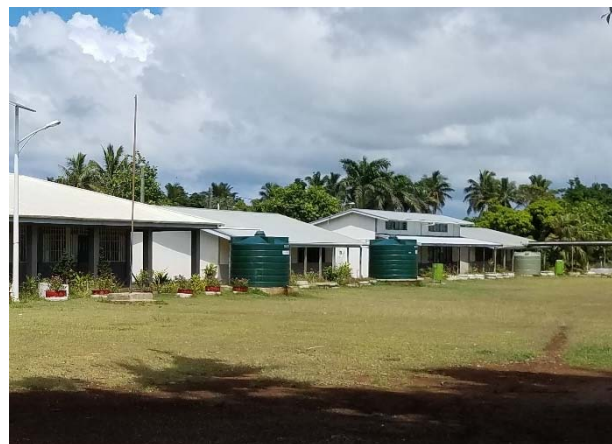
Photo 2.5 Rainwater Harvesting Facility set at School

Rainwater has been utilized as a water source for drinking purpose traditionally in the Kingdom due to the current situation of water supply system. Households or public facilities such as schools and hospitals have their own storage tanks of FRP (Fiber Reinforced Plastics) or concrete next to their facilities and store the rainwater in the tanks collected through the gutters on their roofs (See Photo 2.5). Almost 60 percent of the total population utilizes rainwater for drinking purpose and the rate has become higher in Vava'u as 70 percent compared to other areas (Source: Tonga Census of Population and Housing 2016). In contrast, only ten (10) percent of the population uses tap water for drinking purpose in the Kingdom and also in Vava'u.

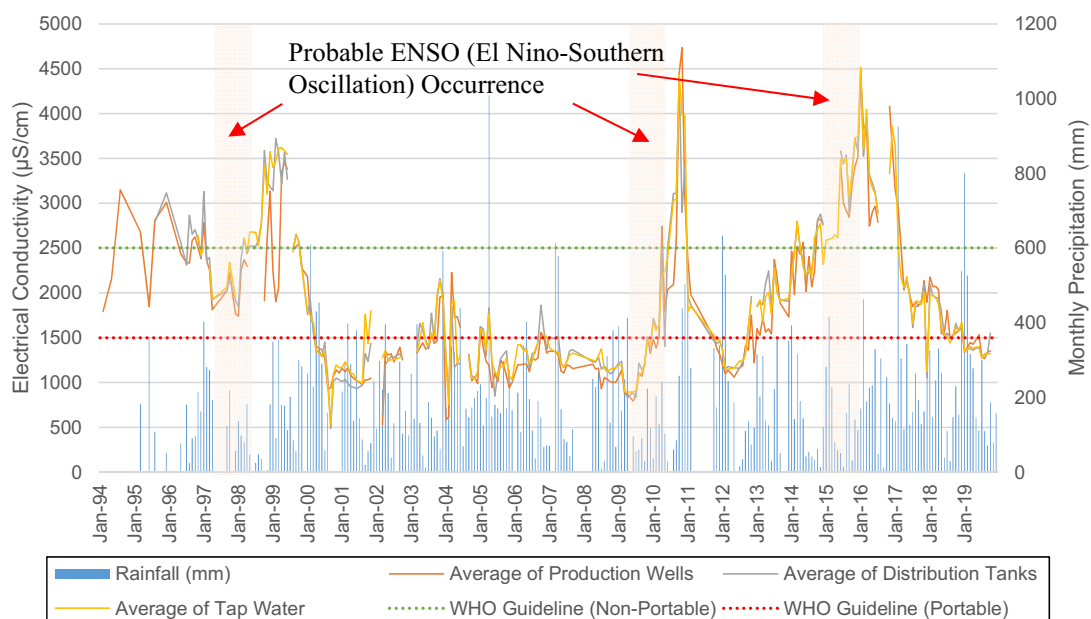
Figure 2.8 shows the transition of the monthly average rainfall for the past 26 years in Vava'u and the EC (Electric Conductivity) of the TWB's supplied water (production well, distribution tanks, tap water). In the south pacific area in the vicinity of the Kingdom, there were probable occurrence of El Niño-Southern Oscillation (ENSO) during the years of 1997 to 98, 2009 to 10 and 2015 to 16 with extremely low rainfall. The EC of the TWB's water, in contrast, were raised just after these periods and can be potentially affected by the ENSO.

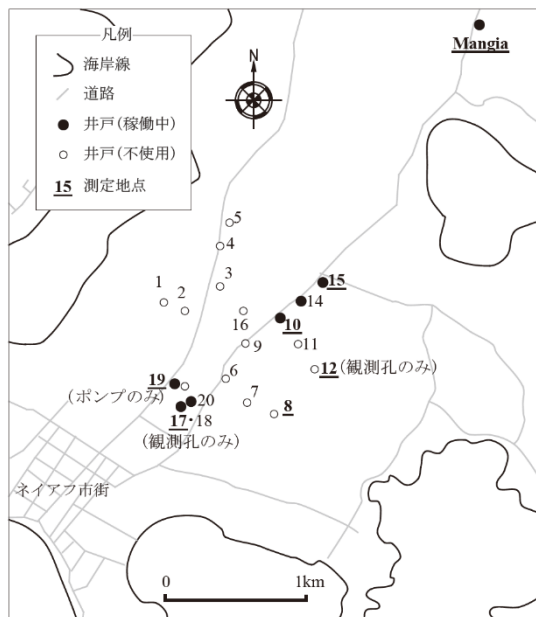
Figure 3.2 Current Well Filed

According to the literature of Japan's National Institute for Agro-Environmental Sciences (No. 217 - 2015) titled "The causes and issues for sea water intrusion to the freshwater lens in Vava'u and Lifuka islands, the Kingdom of Tonga", Ishida, the water quality of the current well field in Neiafu show high EC values exceeding the allowable limit of WHO guideline for portable water (EC: 150 mS/m) at the depth of 8 and 11 m of the well No. 10 and 15 (See Figure 3.2).

The high salinity of the TWB's supplied water is expected to have been caused by the past historical background that 1) number of TWB's production wells had been decreased because of failure of the pumps and clogging of wells since 2000, 2) yield amount per one well had been increased and that 3) finally the "Up-coning", namely, intrusion of sea water to the extracted water occurred at the freshwater lens to accelerate the intrusion. In contrast, the well filed in the north part from the current well field still shows lower EC values even at the deeper level of the wells exceeding 13 m compared to that of the WHO guideline (See No. 18 in Figure 3.3: Mataika and Prison). And also, Table 3.7 shows that lower EC values were observed at the northern parts (in the vicinity of the prison) far from the current well field, which reveals that this area has not been intruded by the sea water with its thick depth of the fresh aquifer and can be a potential candidate site for the new water source.

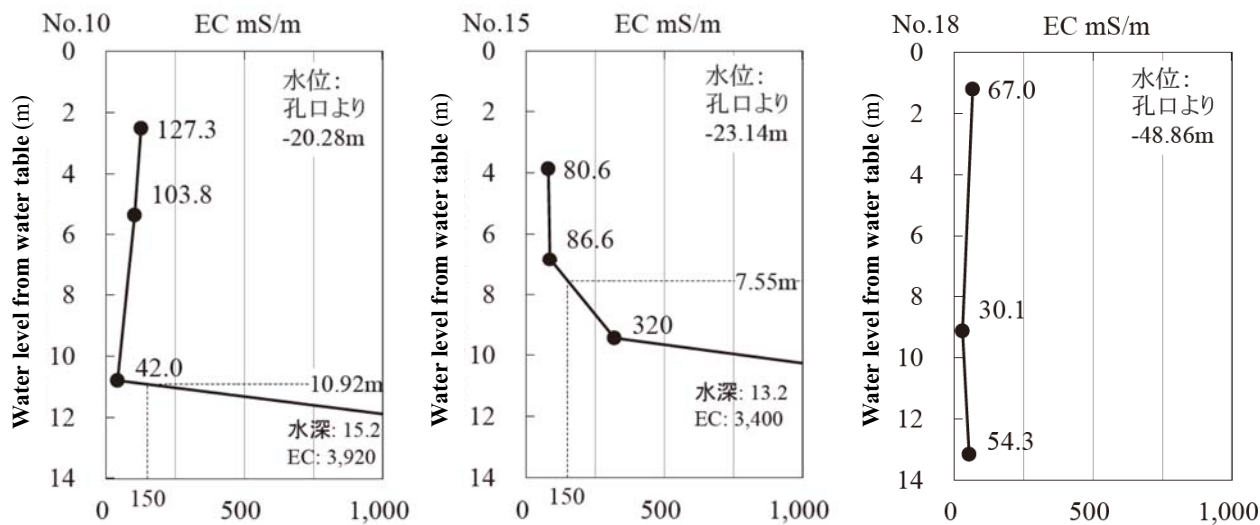
Figure 3.4 Transition of EC Value by Depth at Each Well

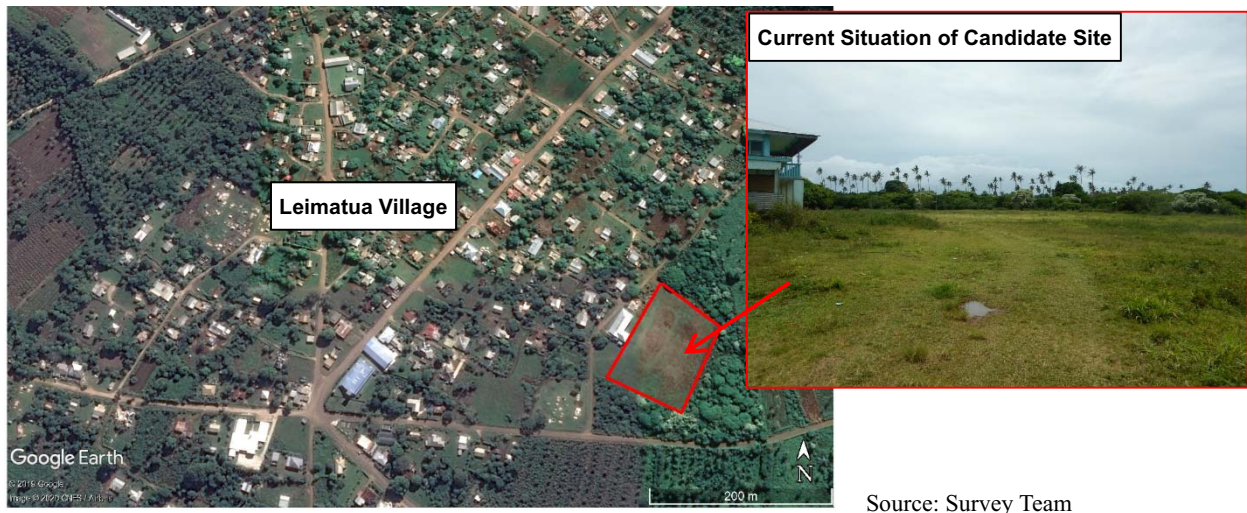
The location and site condition of the candidate site of the new reservoir is shown in Figure 3.10. The site is located in front of the community center of Leimatua village and currently used for a playground and belongs to a noble estate. The land area is around 80 m x 100 m that is enough large to allocate the reservoir of volume of 1,000 m³. Its elevation can also distribute its stored water by gravity to the city center of Neiafu as its current TWB's supply area finally around the city area of Neiafu via the existing reservoir (See Figure 3.6 and Figure 3.11).

Figure 3.10 Location of New Reservoir (Left) and its Site Condition (Right)

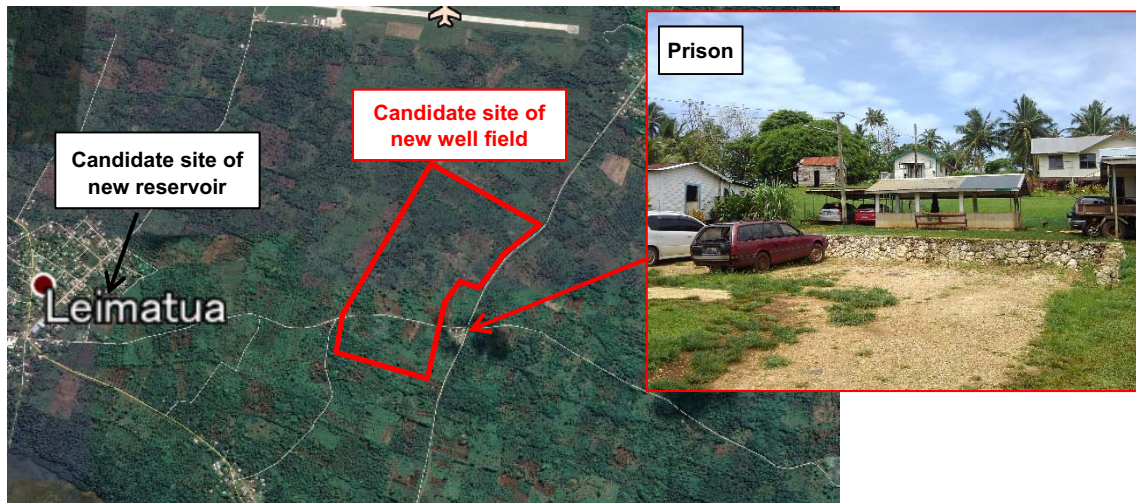
Figure 3.12 Candidate Site of New Well Field (Left) and Condition near the site (Prison)

The project site is located in the vicinity of the existing prison at the middle part between Mataika and Holonga as shown in Figure 3.12. The site appears to be suitable for the candidate site of the well field in terms of its reservation because there is a low risk of the pollution to be caused by the infiltration of sewage and domestic wastewater. There is the existing well in the prison for the water supply to the surrounding

villages, and it is confirmed that its water quality is more suitable for the water source with its lower EC level compared to the existing water source and that its aquifer appears to be thicker.

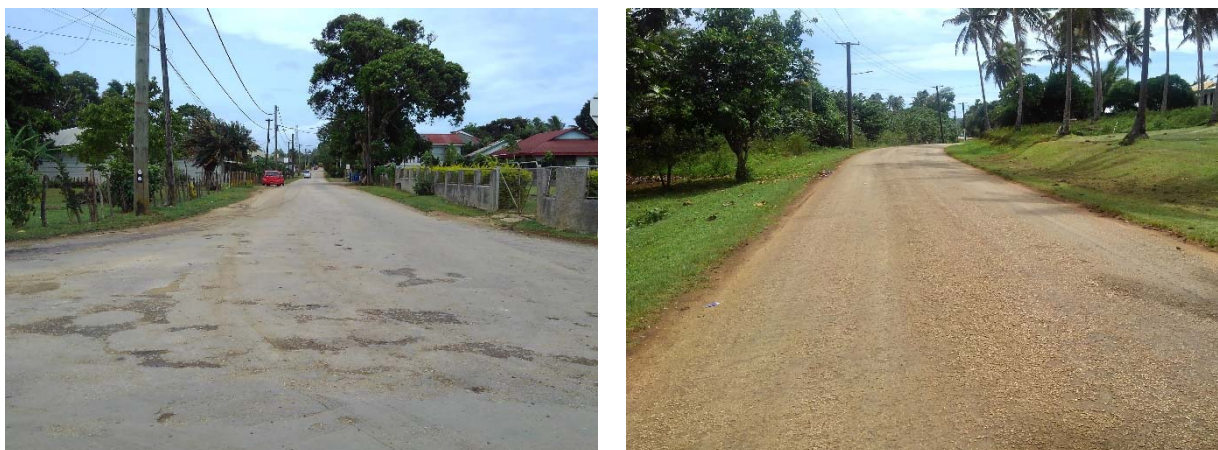
Photo 3.2 Road Conditions in Vava'u

(Left: Concrete pavement, Right: Concrete pavement using aggregates of coral limestone)

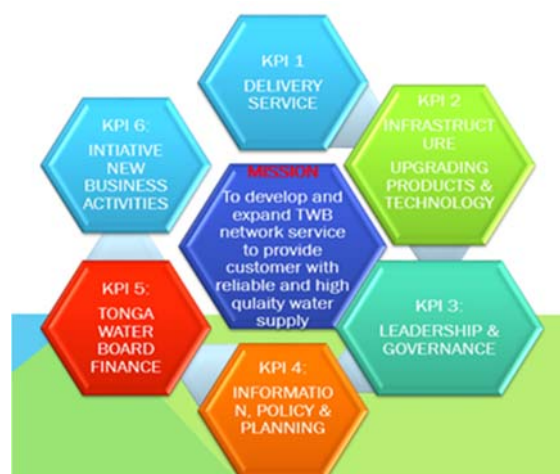
Figure 5.2 Relation Diagram of KPI for Water Supply Service

KPI 4: Information Policy & Planning	<ul style="list-style-type: none"> • Lost time accidents are routinely reported and are within annual targets • Non-compliances with safety procedure are reducing annually • Improve health standard and perception of customers.
KPI 5: Tonga Water Board Finance	<ul style="list-style-type: none"> • \$30,000 of domestic plumbing repairs income in the first year and \$40,000 in the following years; • \$50,000 of new installation income in the first years and \$65,000 in the following years; • Drilling rig operational within first year and 3 drills completed each year to earn \$100,000 consecutively. • Consultancy income of \$30,000 • Revenue increases by more than 10%
KPI 6: Initiative New Business Activities	<ul style="list-style-type: none"> • 200 domestic plumbing repairs in the first year and 500 repairs in each of the following years; • 100 new installations in the first year and 200 in each of the following years • NPAT of the water bottling venture to be >TOP1.5m pa after FY 18-19 and TOP2m pa after each following FY 20-21
